LAKESIDE PARK

Cultural Landscape Report

History, Existing Conditions, Analysis & Rehabilitation Plan

City of Fort Wayne, Department of Parks & Recreation
Fort Wayne, Indiana

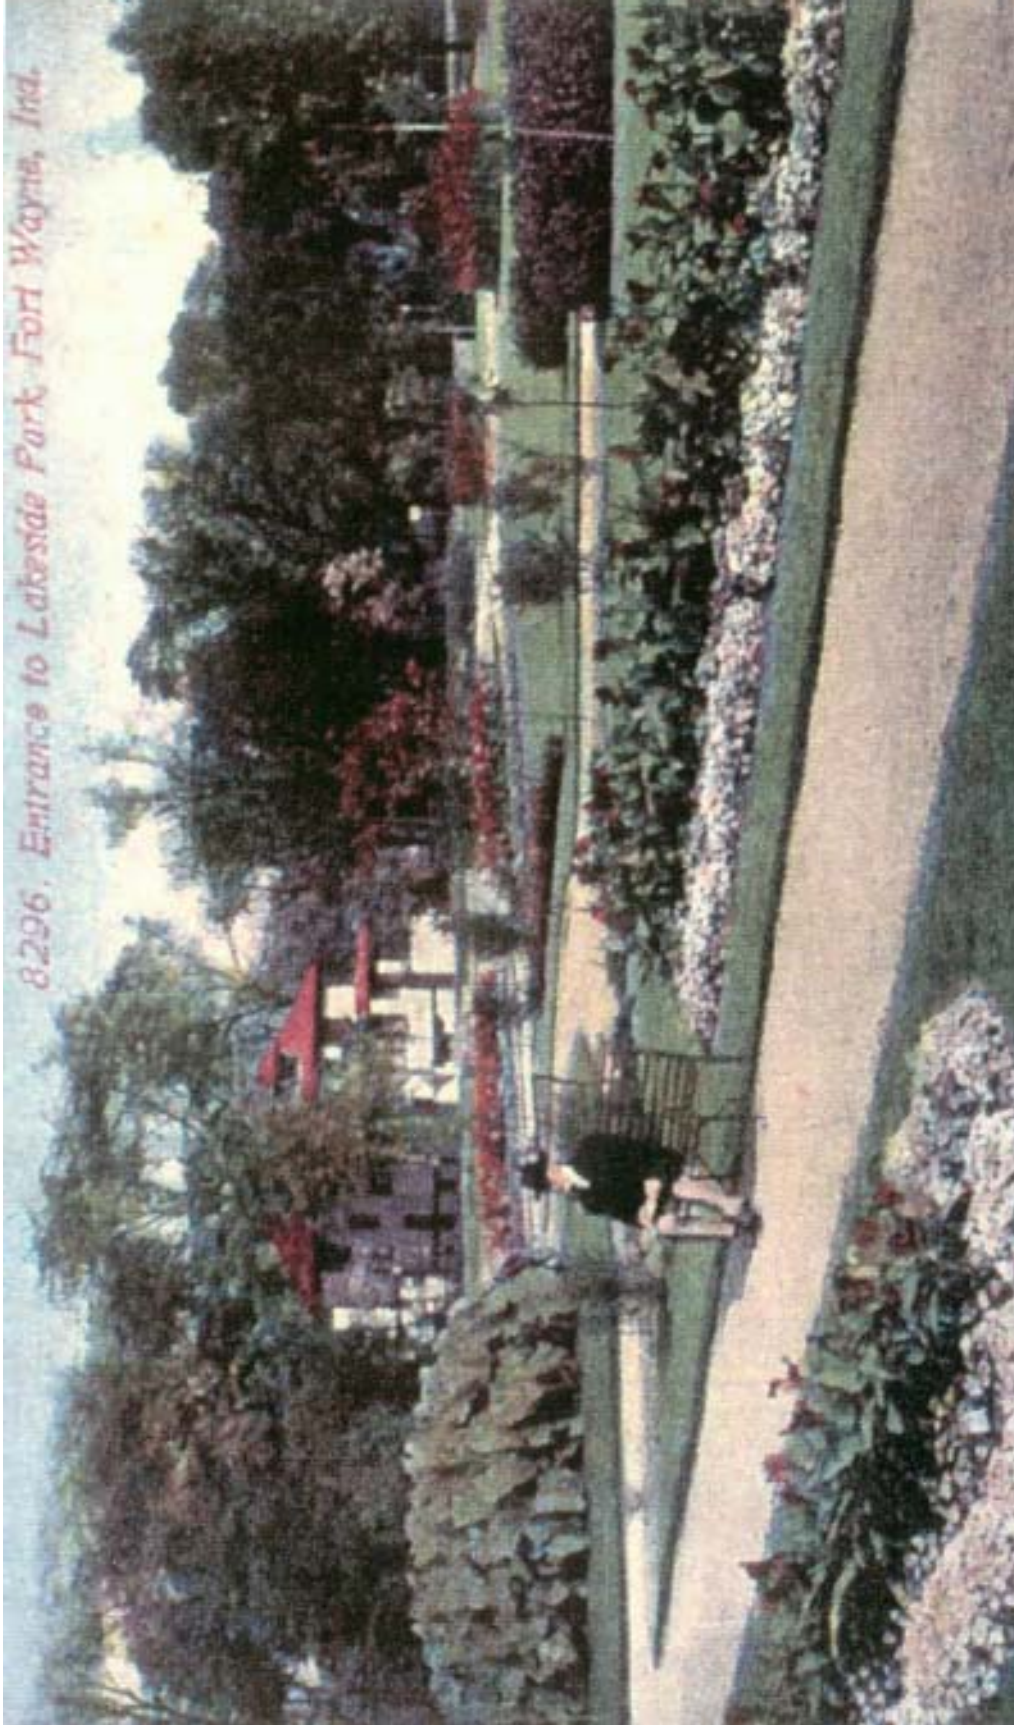
Figure 1.6 “Map of Lakeside Park”, 1912. It was actually a proposed plan drawn by Henry J. Doswell, Superintendent of Lindenwood Cemetery in Fort Wayne. Courtesy of Fort Wayne Parks & Recreation.

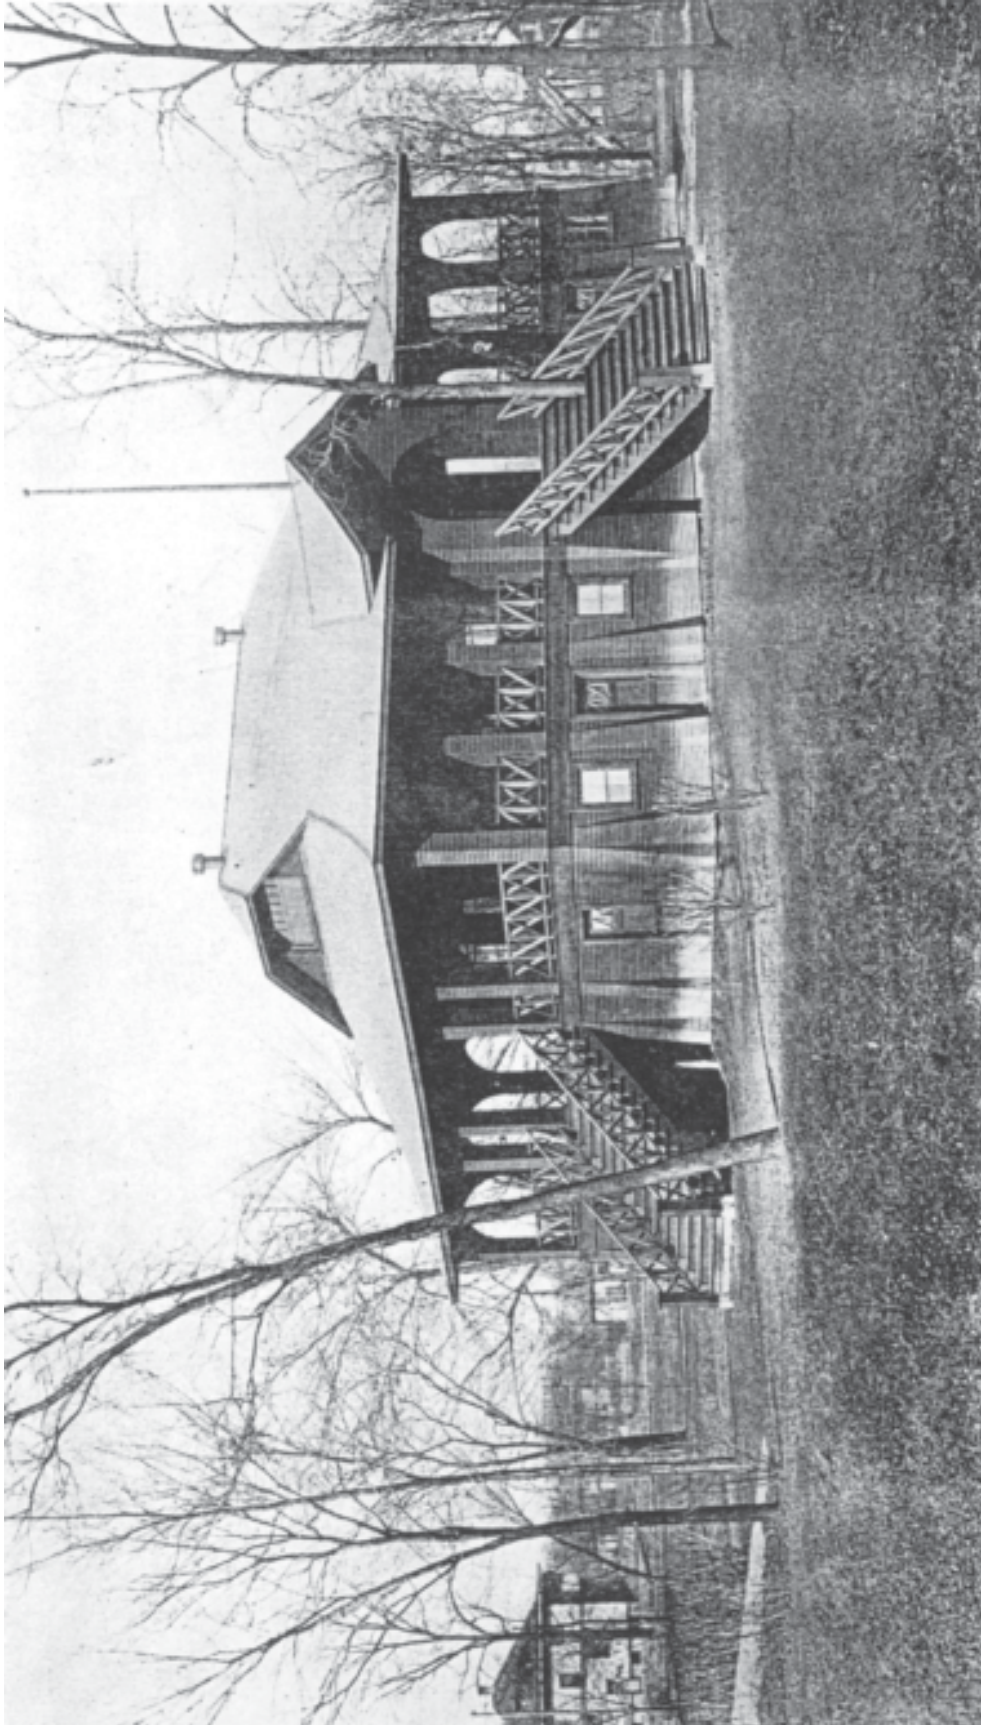
Figure I.10 The newly constructed refectory/bathhouse/comfort station located on the central island in the Lagoons, 1916. 1916 Annual Report, p. 34. Courtesy of Fort Wayne Parks & Recreation.

The Lakeside Park refectory, which also served as a comfort station and boathouse to replace the one removed in 1911, was built by 1916 but not completed until 1918.¹³ A 1916 photograph of the structure can be seen in Figure I.10. It was located on the second of three islands constructed in the Lagoons on the west side of the park. In 1917 a wide rustic bridge was built to the island to access the refectory.¹⁴ Narrower bridges had likely already been built.

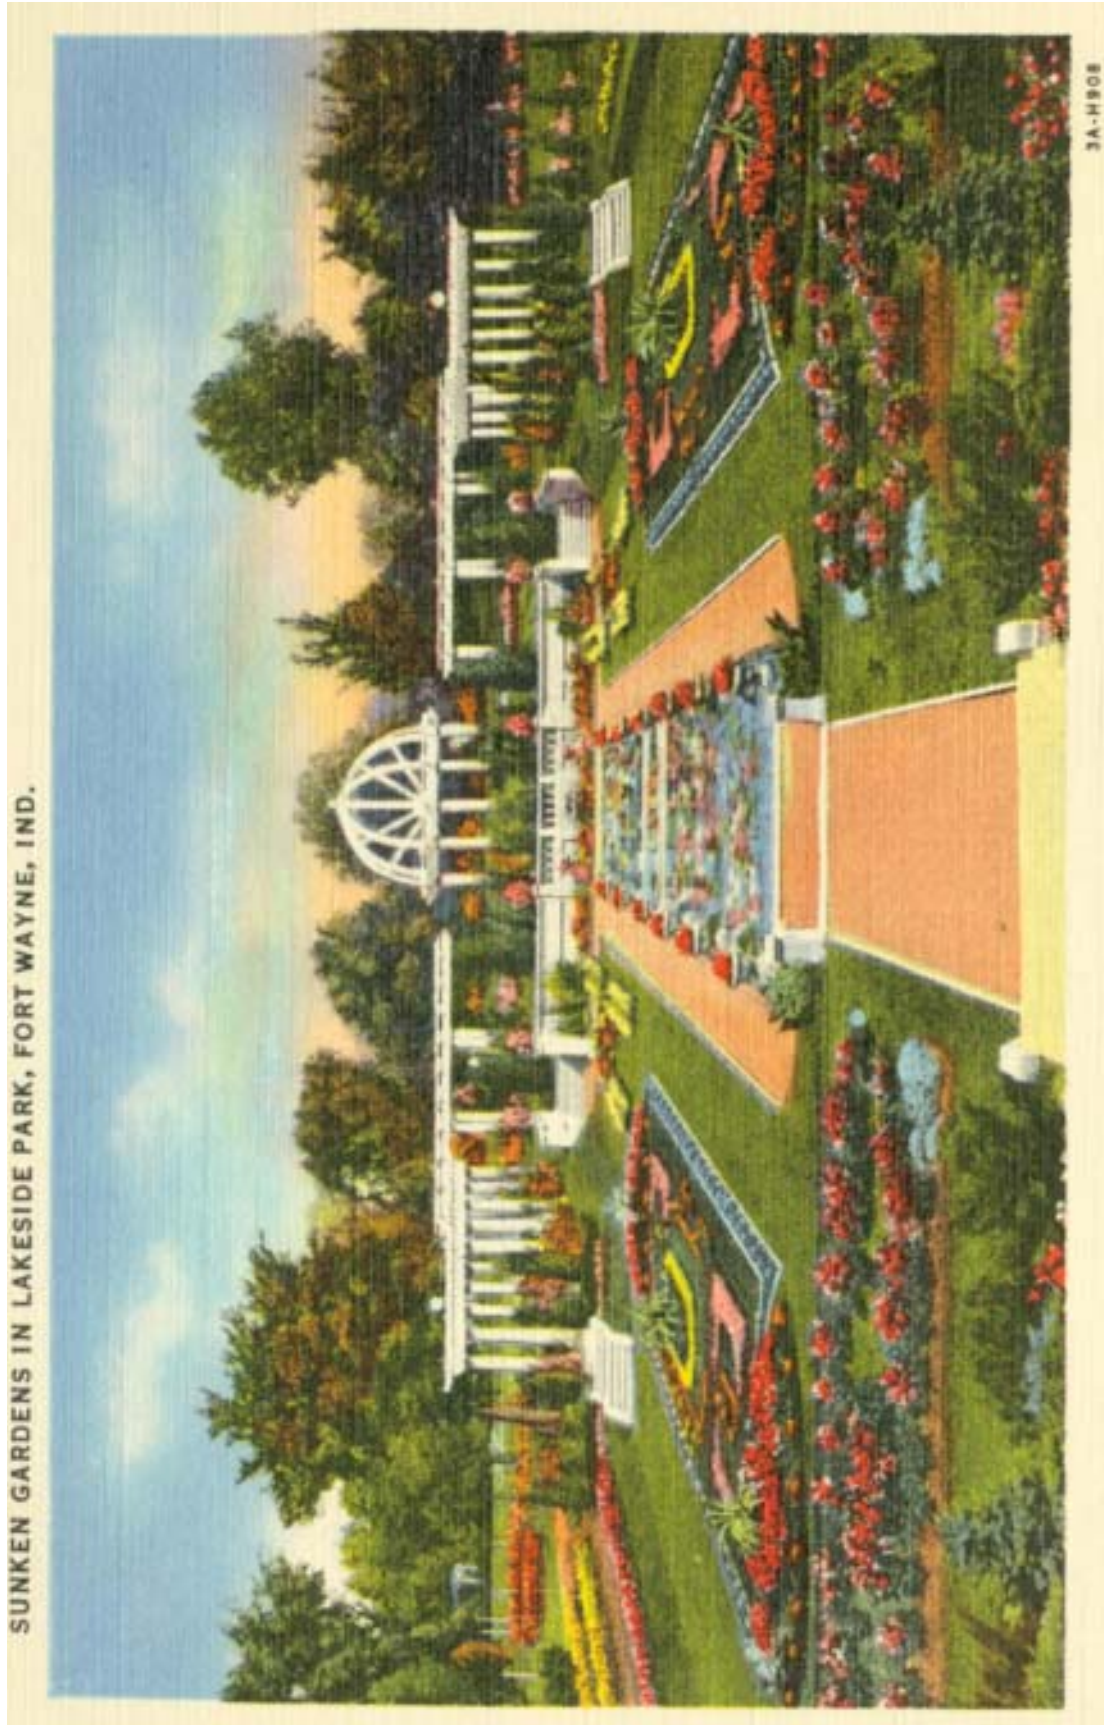
Figure I.12 Postcard of the Sunken Garden, c. 1930. Courtesy of Allen County/Fort Wayne History Center.

¹ Although this comparison in this chapter is between 1949 and 2002, Figure IV.2 shows a number of elements from the 1920s and 1930s that were gone by 1949. These include the pergola dome, globes or globe lights on the southern ends of the two flanking pergolas, and pedestals containing urns on the east and west sides of the entrance. The beds were also substantially different, as seen in Figure IV.2 and also Figure I.12.

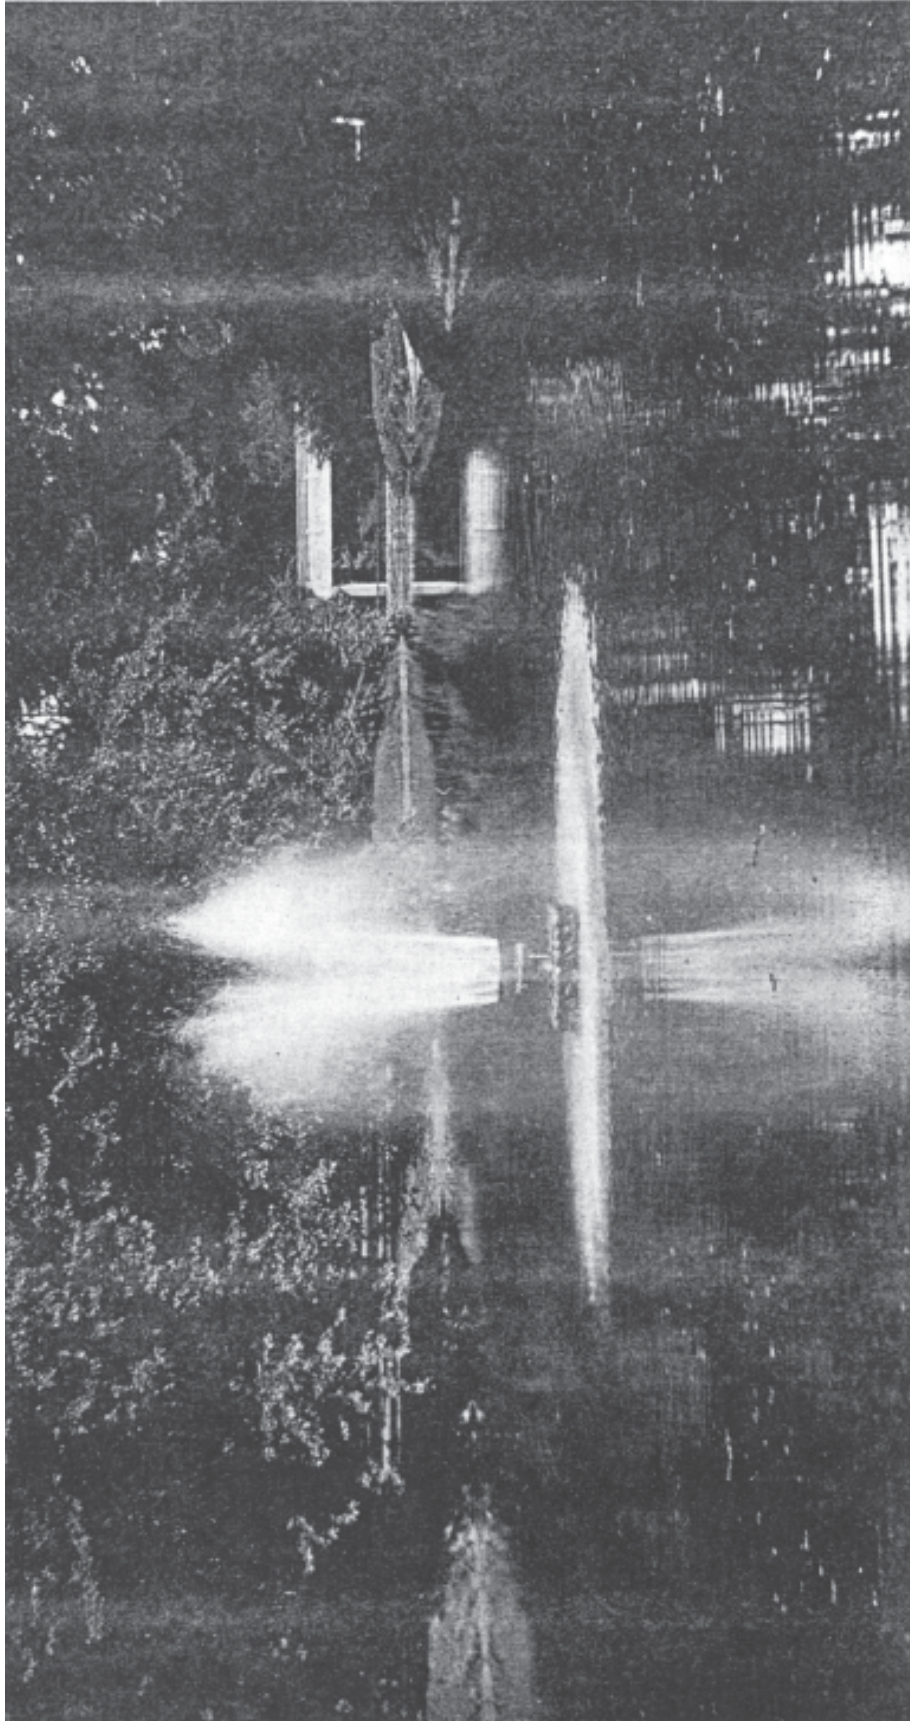
Figure I.13 One of five fountains located in the Lagoons, installed for use in the fish hatchery process that operated in the late 1920s and early 1930s. 1933 Annual Report. Courtesy of Fort Wayne Parks & Recreation.

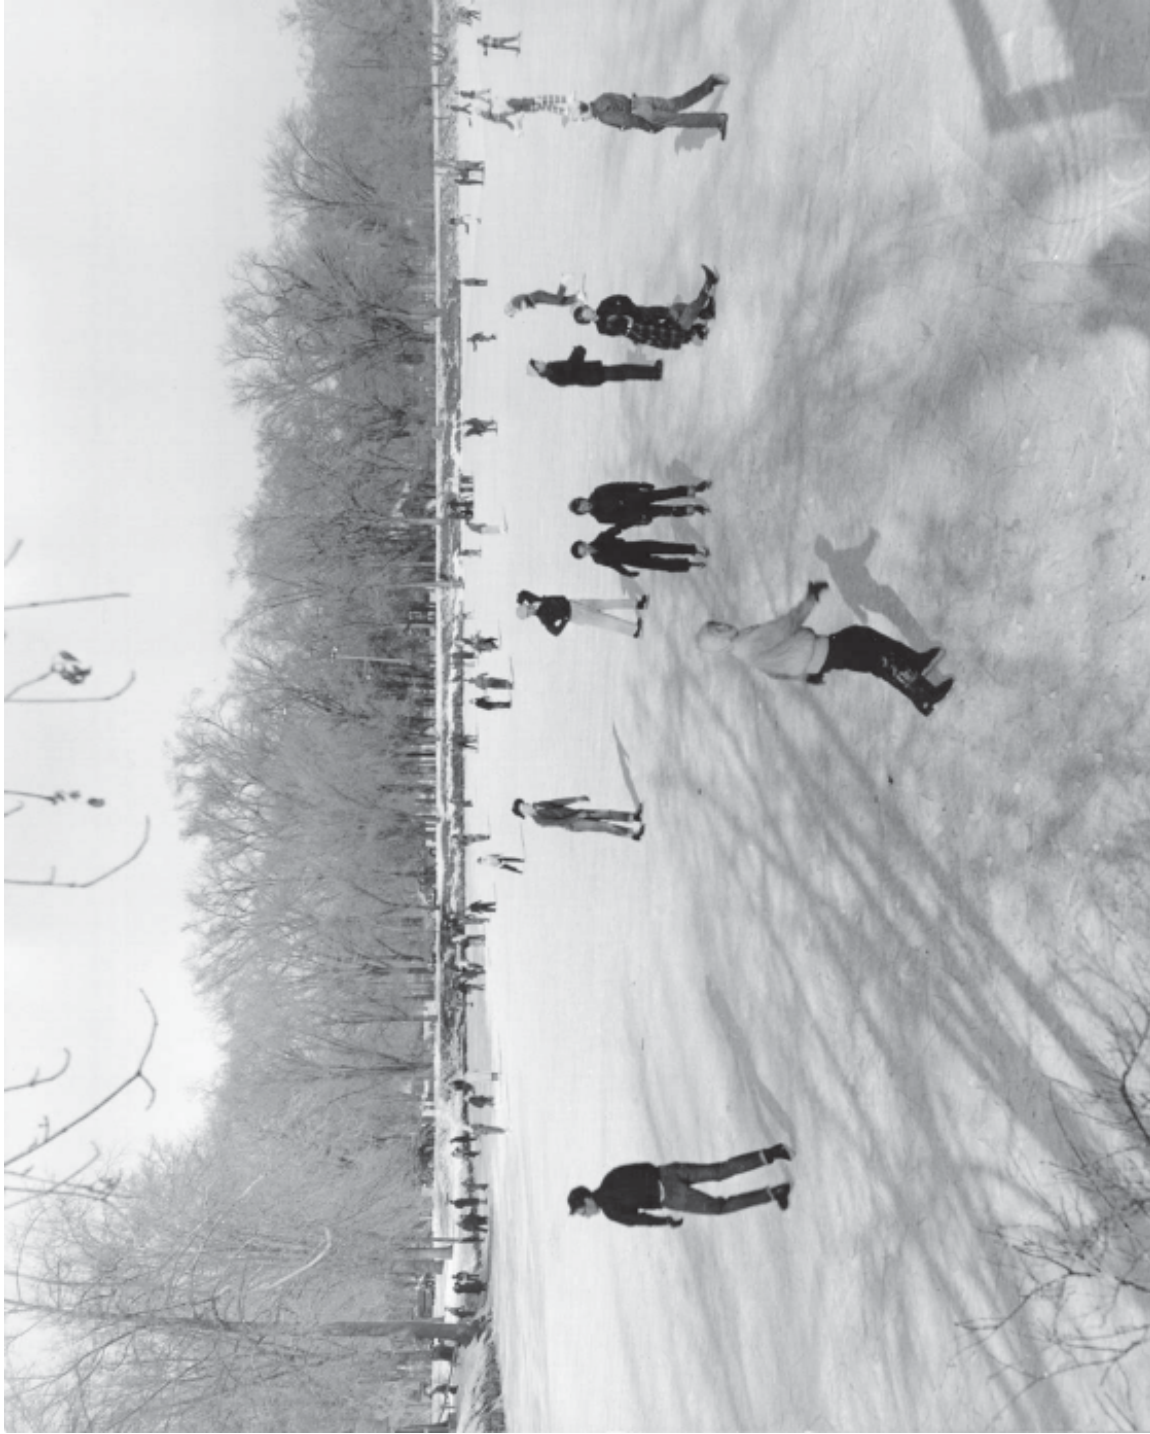
Figure II.9 View from the Columbia Avenue bridge north of ice-skaters on Delta Lake. The ice access ramp can be seen on the left, and the refectory is faintly visible to the right of center. Courtesy of Allen County Public Library, 00001503.

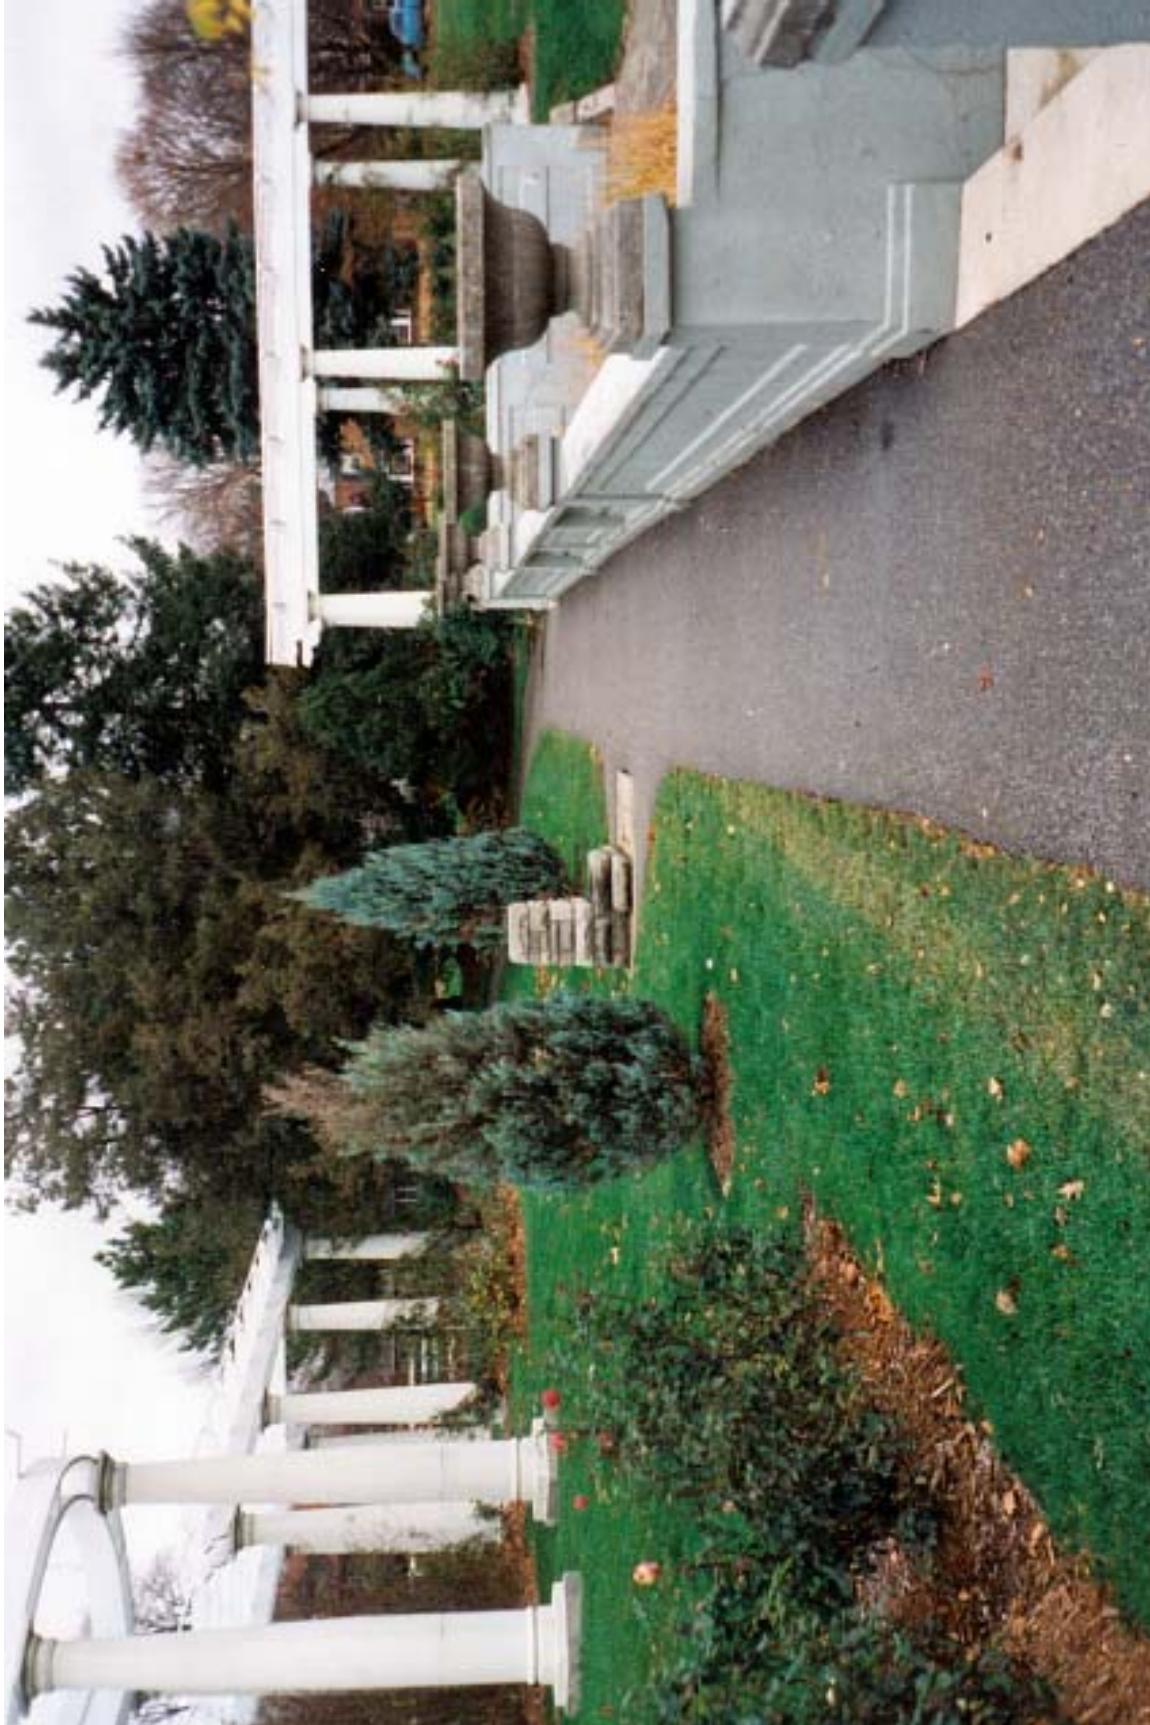
Figure III.4 The east/west path on the north side of the Sunken Garden's balustrade, showing the drinking fountain flanked by two recently planted evergreens. LANDSCAPES LA•Planning•HP.

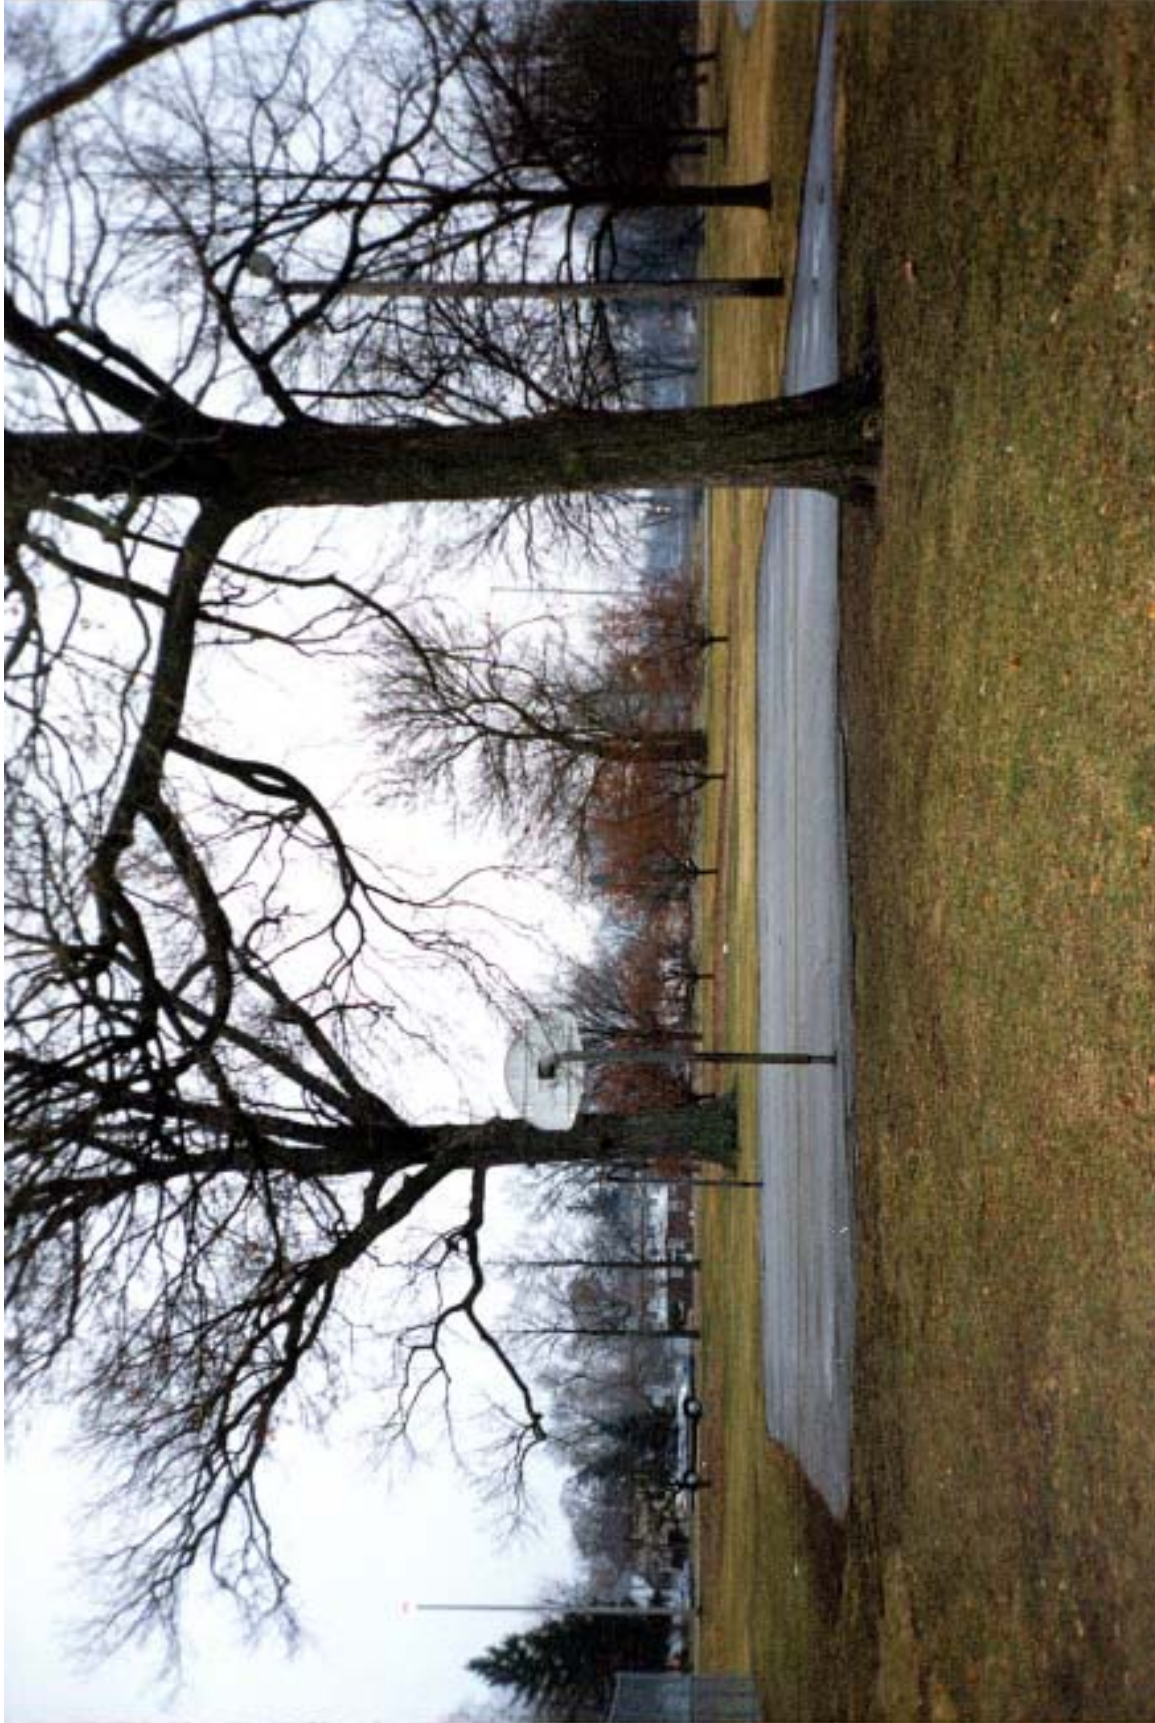
Figure III.9 View of the larger of two asphalt paved basketball courts, situated west of the tennis courts. Between the two courts there is only one backstop, seen here. LANDSCAPES LA•Planning•HP.

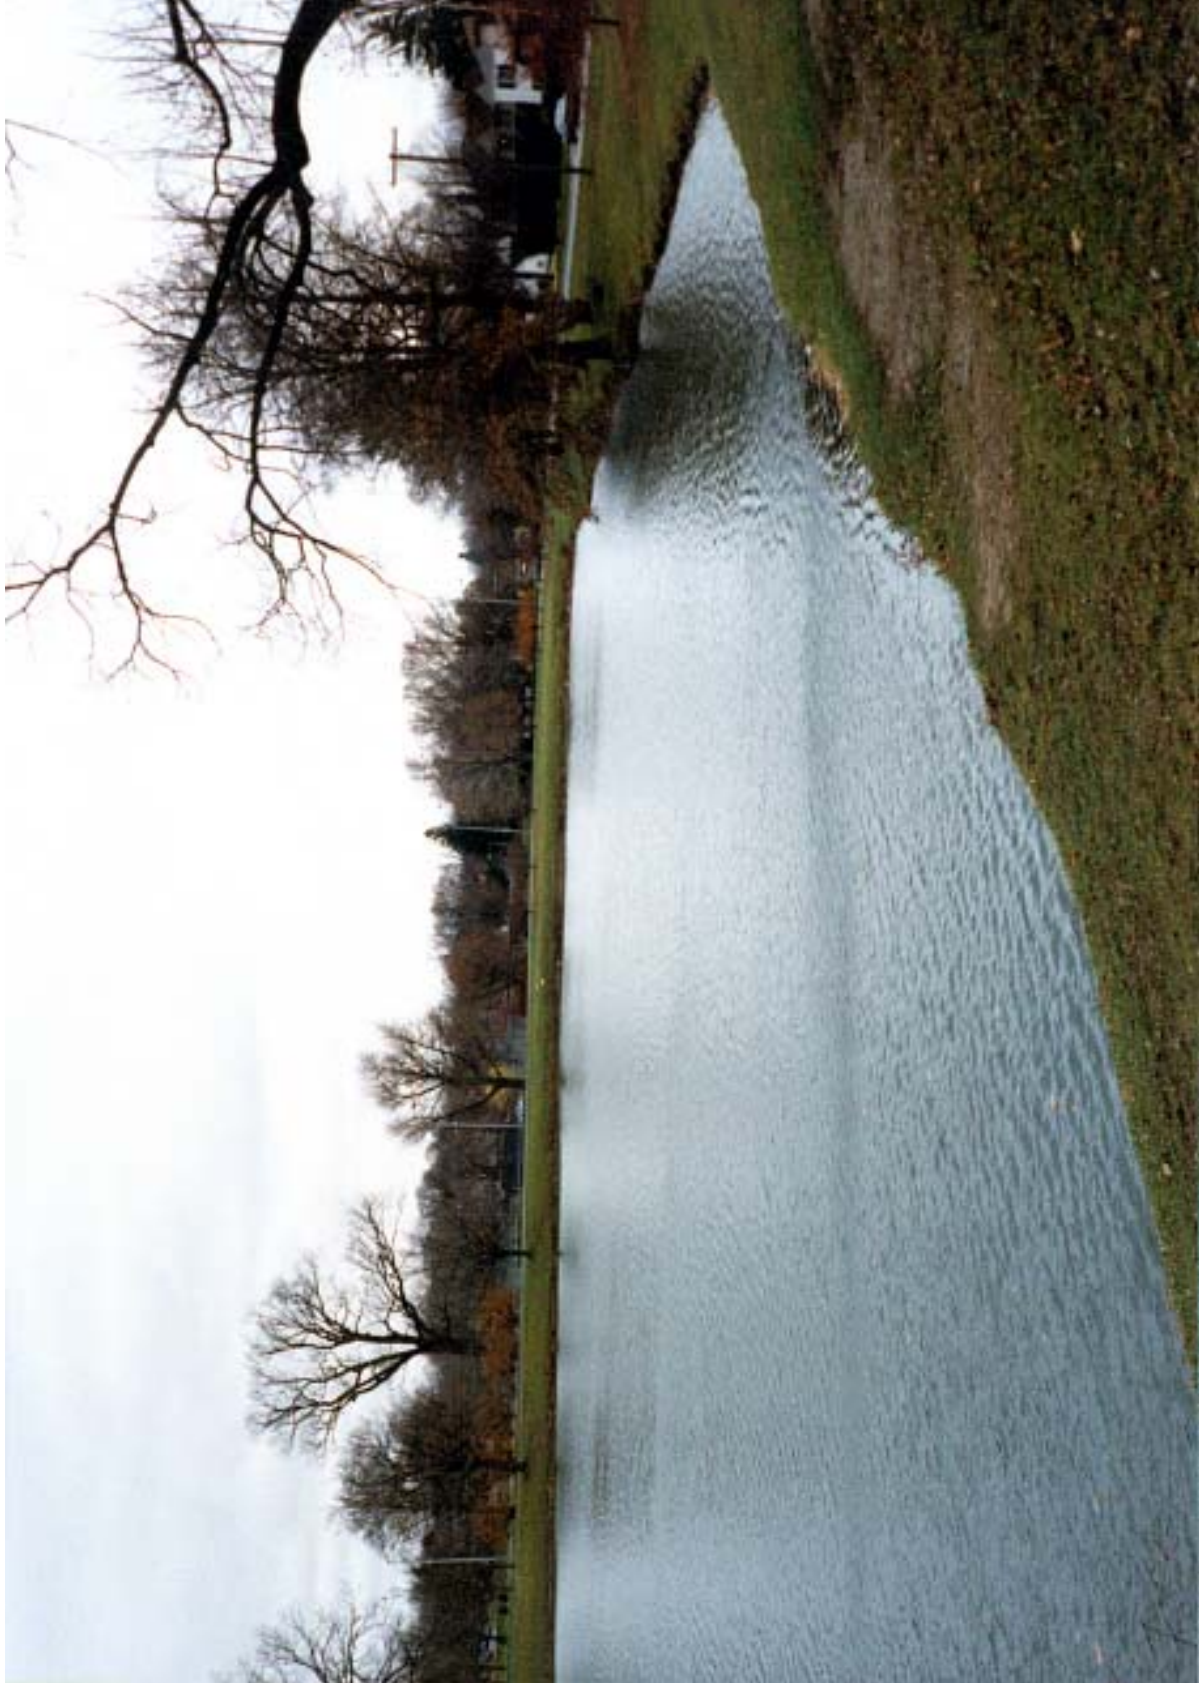
Figure III.11 The eastern side on the north half of Delta Lake, looking north towards Lake Avenue. LANDSCAPES LA•Planning•HP.

The Delta Lake landscape unit is separated from the remainder of the park by Lake Avenue. North of Columbia Avenue is the larger part of the lake, with mown banks and large trees at the water's edge, as seen in Figure III.11. In the northeast corner, at the convergence of Lake Avenue and Delta Boulevard, there is a flat triangle of land containing eleven crabapples. West of the lake is a lightly wooded area containing the Lawton memorial, seen in Figure III.12. It is located on a small mound of turf. The banks of the southern half of Delta Lake also contain large trees, as well as sections of dense understory growth, as seen in Figure III.13. Portions of the banks on both halves show signs of erosion and high foot-traffic. In some instances the slopes are beginning to fail, and in other locations sections of the bank have been stabilized with rock or riprap.

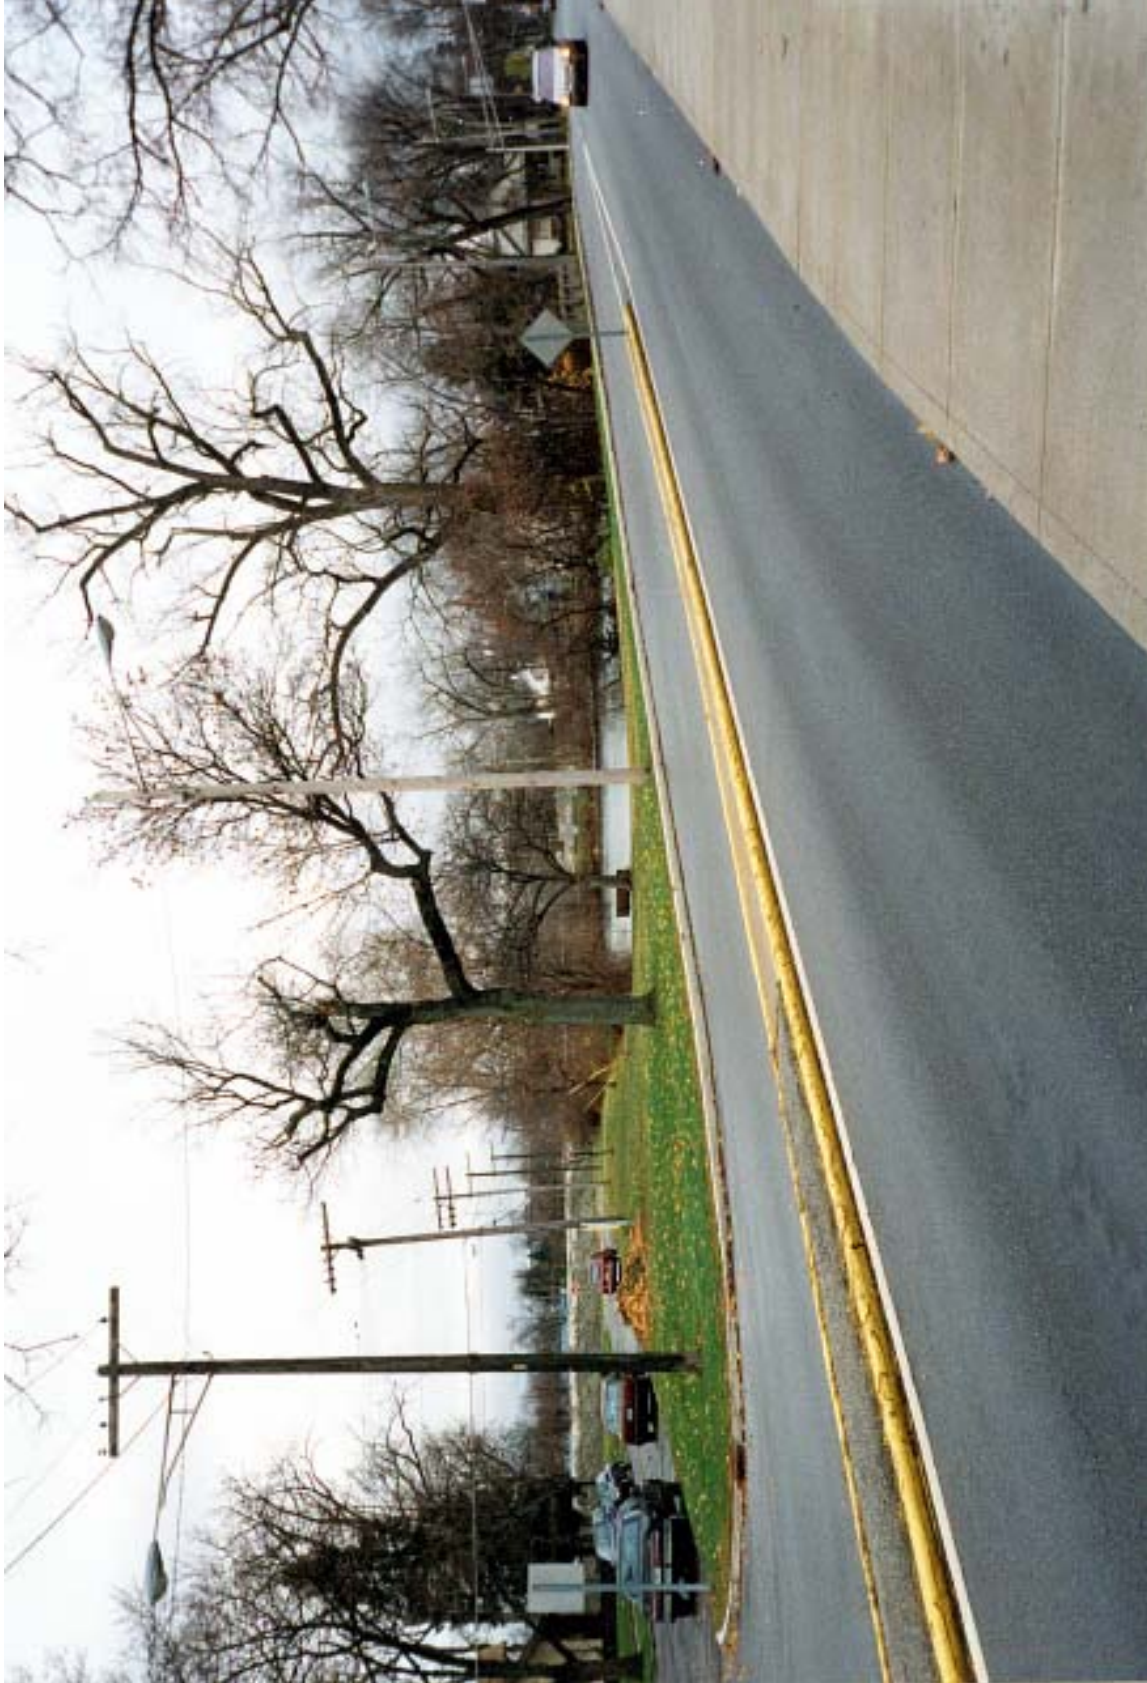
Figure III.13 View southwest of Columbia Avenue and the densely vegetated banks of the southern half of Delta Lake. LANDSCAPES
LA•Planning•HP.

The only defined paths in this unit are the sidewalks on the north and south sides of the northern section. Footpaths are worn along portion of the lake's perimeter. Columbia Avenue crosses Delta Lake with a bridge containing reinforced concrete rails that are showing signs of failure. The Lawton memorial is damaged, as Lawton's sword is missing. There are no other notable site furnishings in this landscape unit.

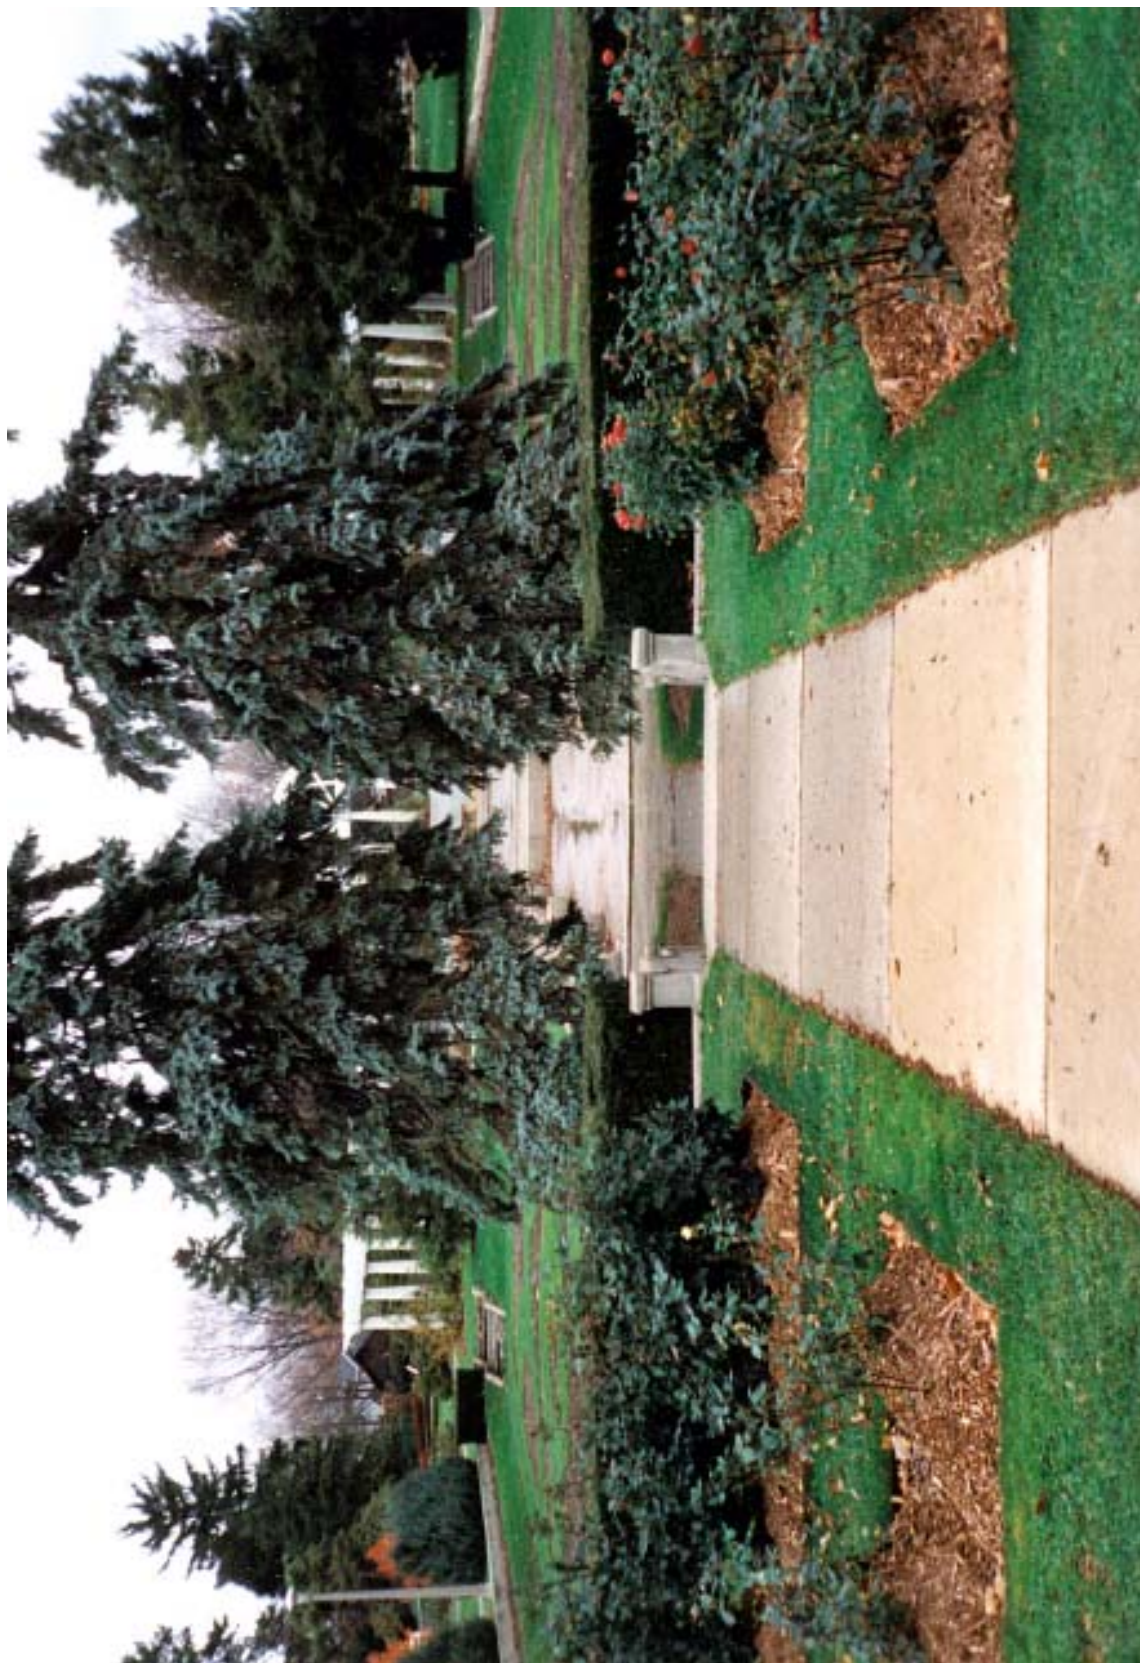
Figure IV.1 Contemporary view from Lake Avenue down the central axis of the Sunken Garden, which is blocked by the large evergreens.
LANDSCAPES LA•Planning•HP.

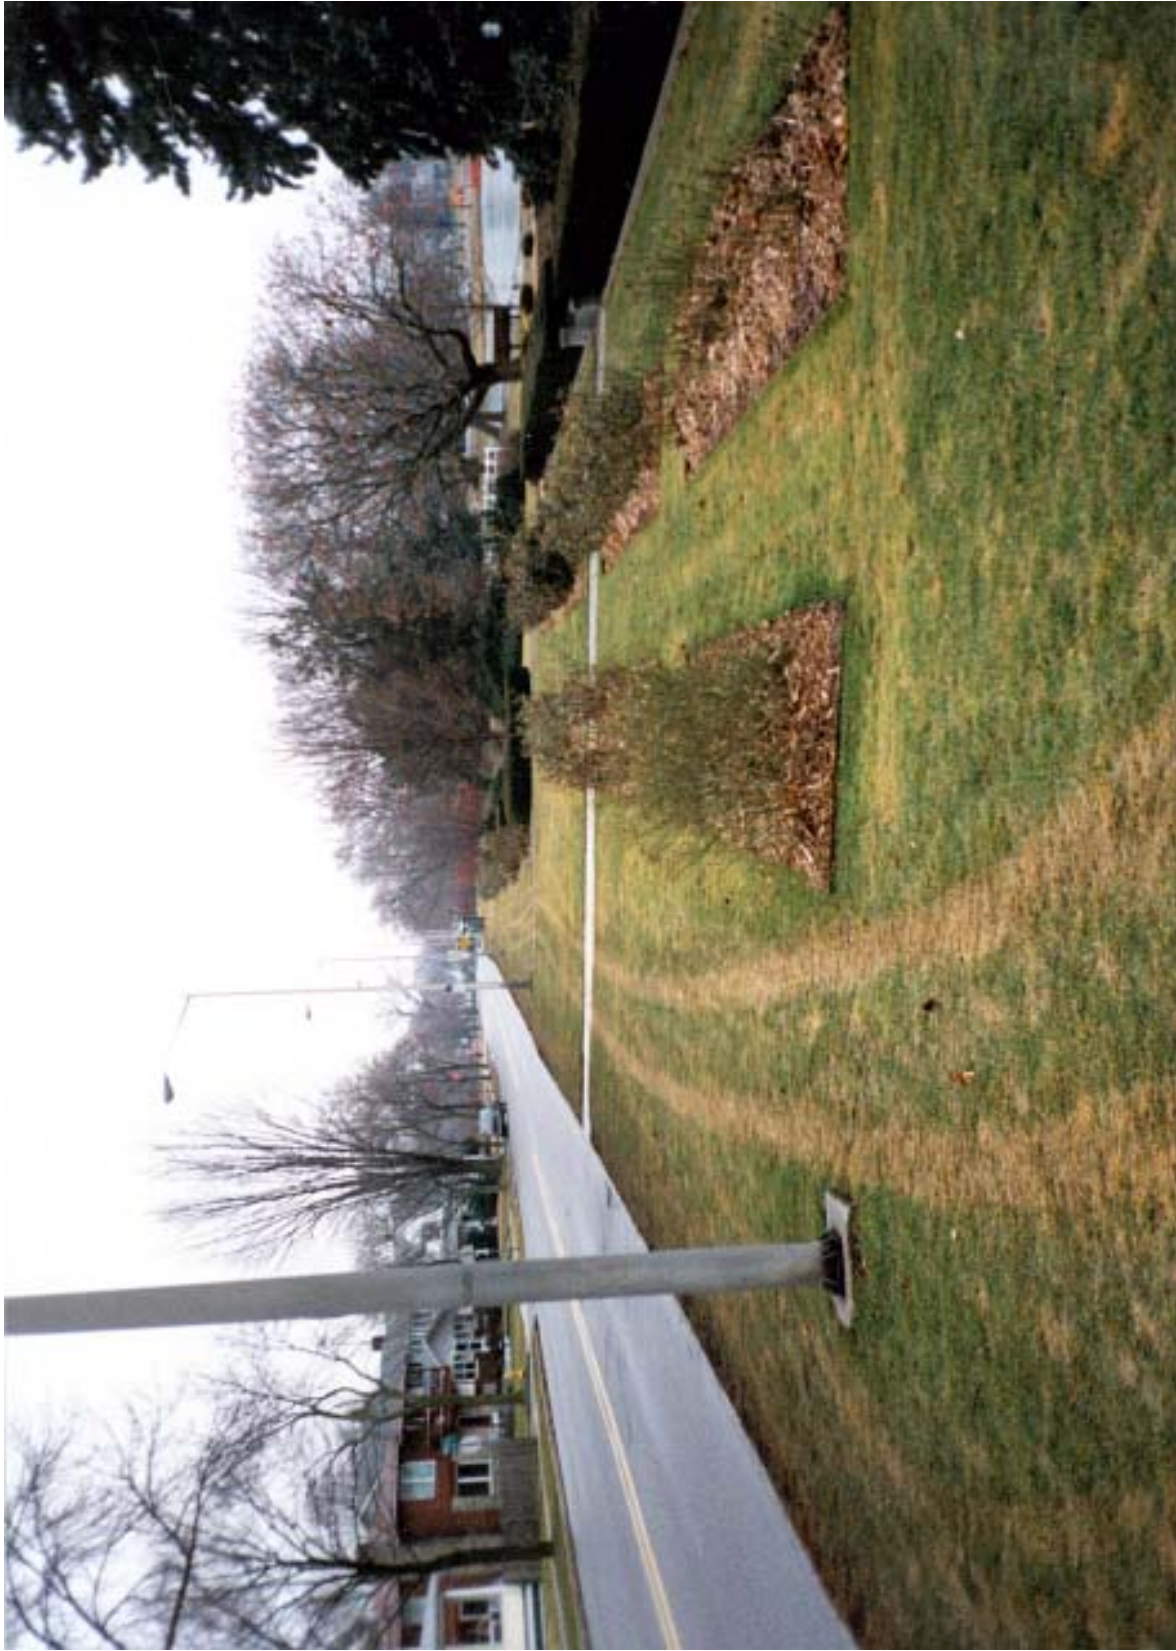
Paths have remained fairly consistent between the two periods, with the exception of the handicap access ramp added to the west pergola. Paving materials have changed, however, with the contemporary use of asphalt and gray concrete pavers. Turf paths between beds have of course been altered with the redesign of the beds themselves. There are some instances, however, where foot traffic and service vehicle traffic have worn the lawn, as seen in Figure IV.3.

Figure IV.3 Path worn by service vehicles in the Rose Garden, along Lake Avenue. LANDSCAPES LA•Planning•HP.
