LAKESIDE PARK

Cultural Landscape Report

History, Existing Conditions, Analysis & Rehabilitation Plan

City of Fort Wayne, Department of Parks & Recreation
Fort Wayne, Indiana

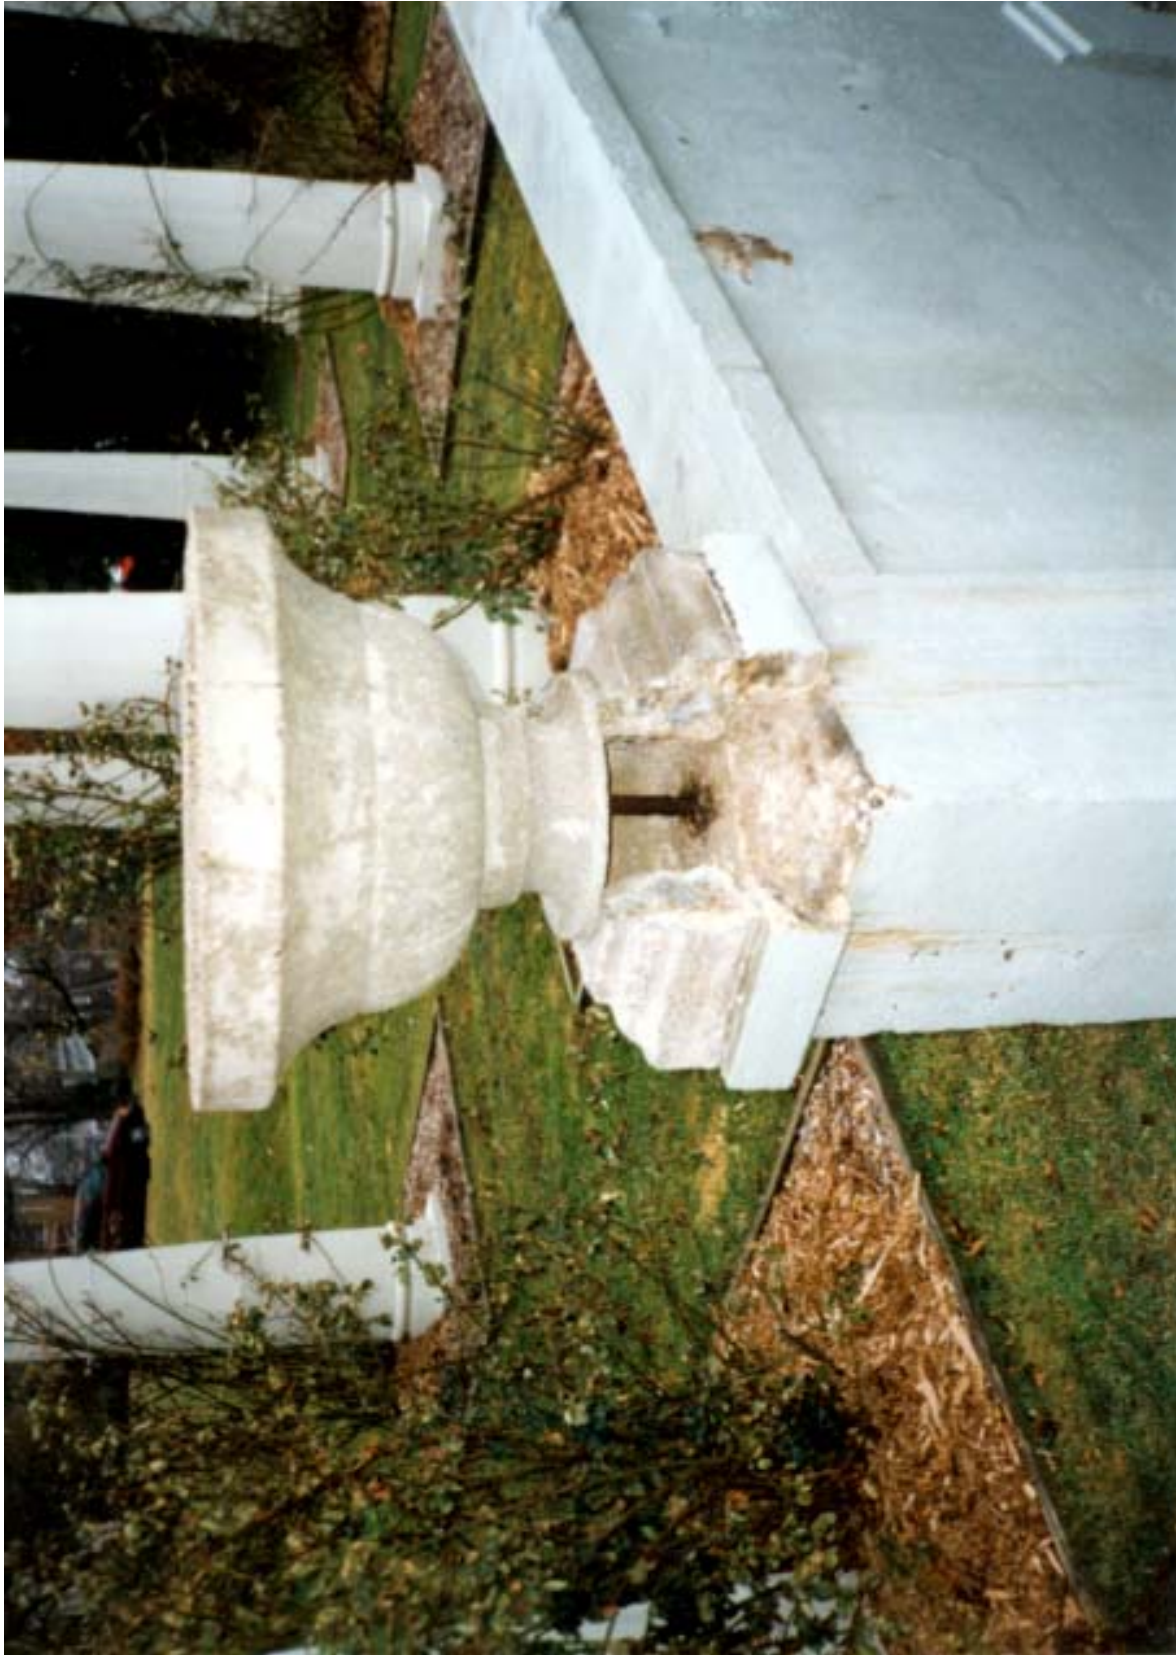
The pools, wall and structures of the gardens remain, although many are in poor condition to the point of eminent failure. Exceptions include the pergolas, which have been recently rehabilitated. The urns are in poor condition, as seen in Figure IV.4, but are currently being molded for accurate replacement by FWPR. Many of the walls are also in poor repair. The pools are filled each year but the plumbing that allowed water to flow through them does not function. Vandals have broken the fountain at the head pool seen in Figure IV.5, but attempts to restore it are also underway.

Figure IV.4 Damaged base of urn and wall in the Sunken Garden. LANDSCAPES LA•Planning•HP.

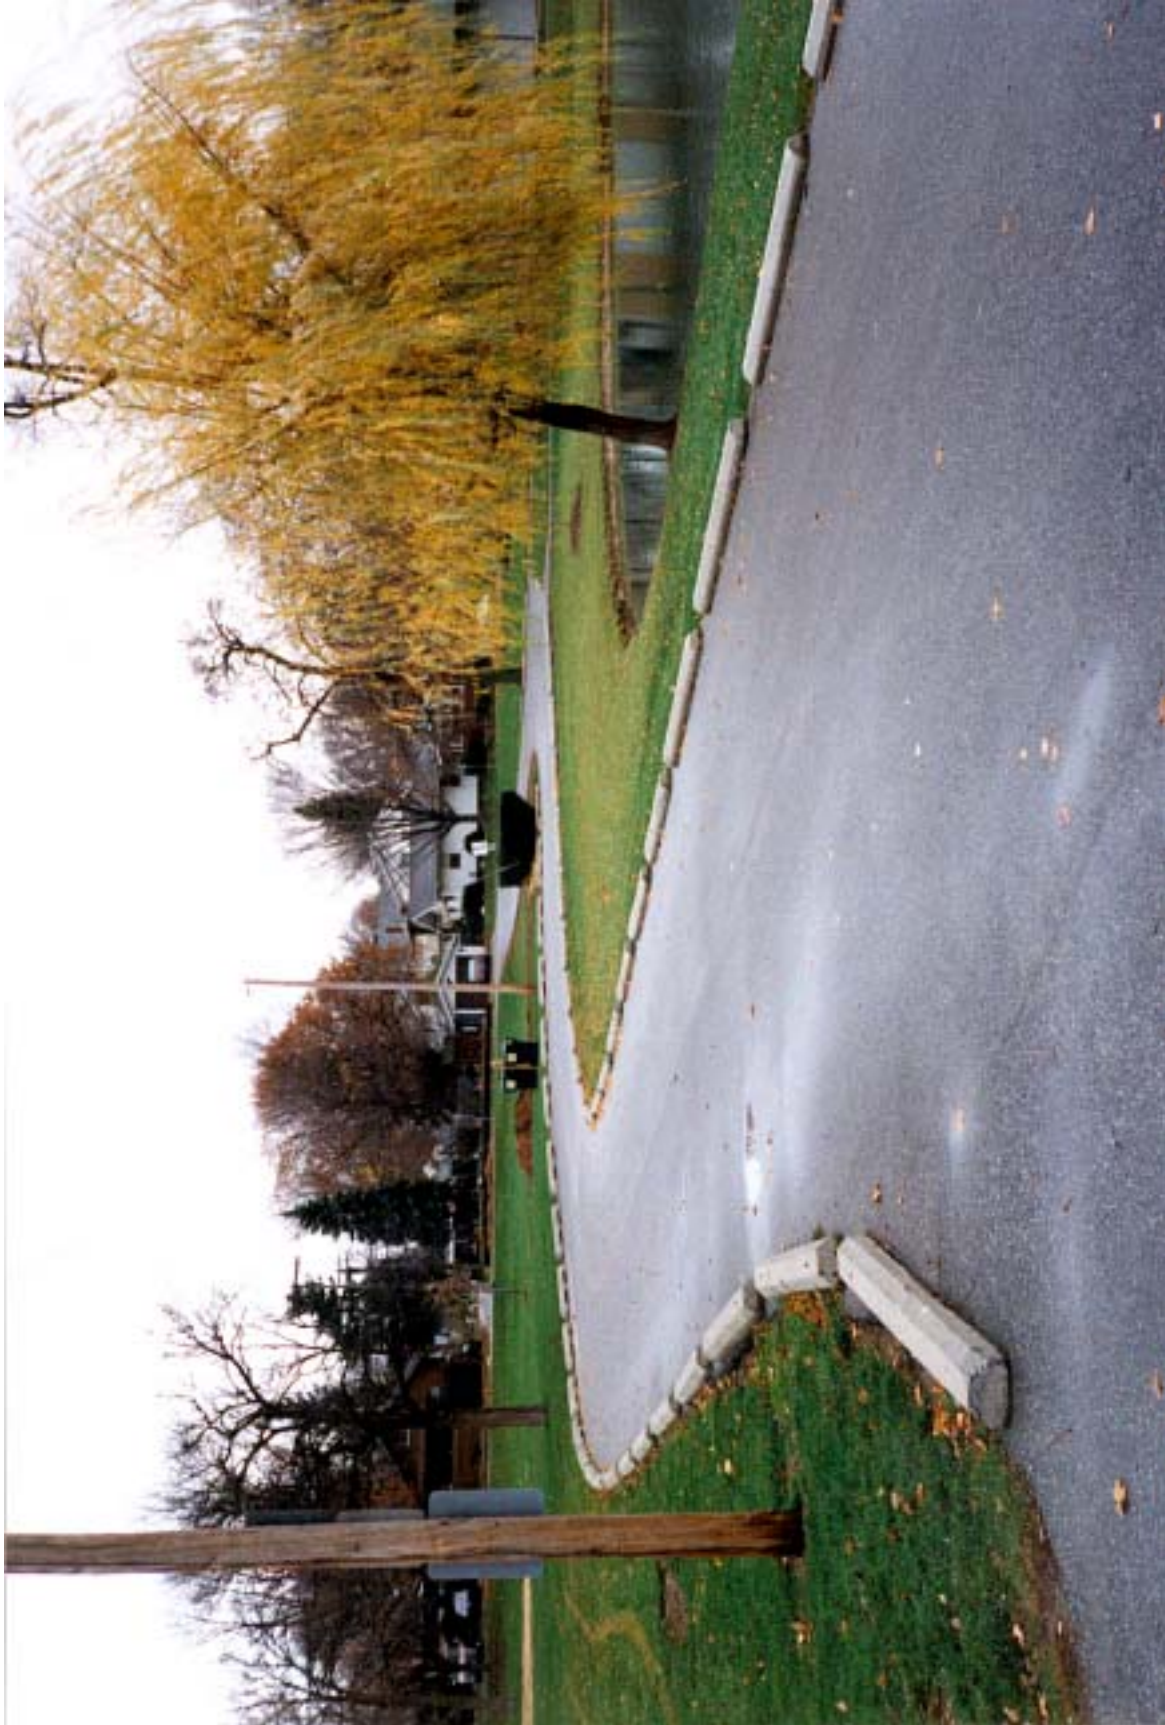
Figure IV.7 The utilitarian parking lot access, with utility poles and boxes, fire-stop curbs and signage. LANDSCAPES LA•Planning•HP.

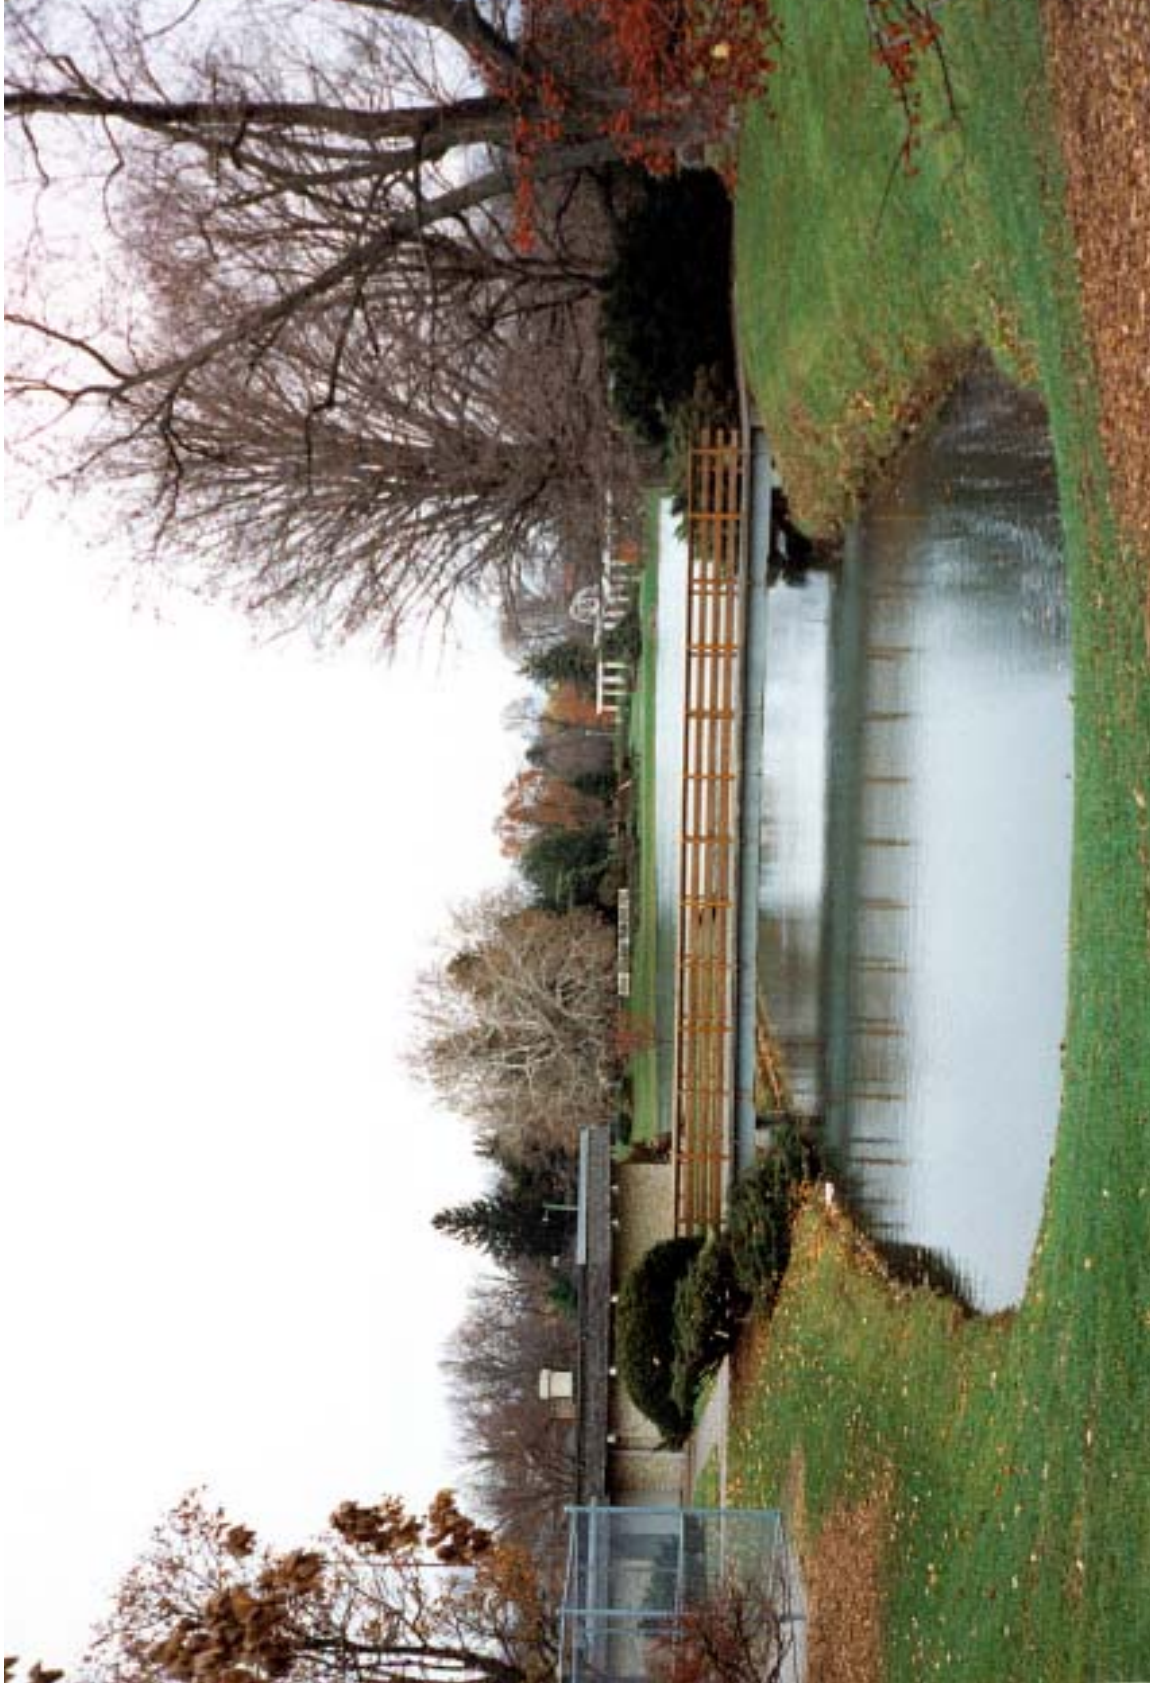
With the exception some of the walks at pavilion #2, the extensive system of paths and bridges that accessed this unit in 1949 is gone. There is a path around the playground and a bridge over the remnant of lagoon #5, seen in Figure IV.8, but it differs in both design and location. The original bridges were not flat, but contained ramps at both ends and a different railing, as seen in Figure IV.9. The two pavilions found in the park today are also very different in design style and feel than the original foursquare refectory on the central island.

Figure IV.8 View of the pedestrian bridge over the extended arm of the skating lagoon, with the corner of the tennis courts and pavilion #1 visible on the left. LANDSCAPES LA•Planning•HP.

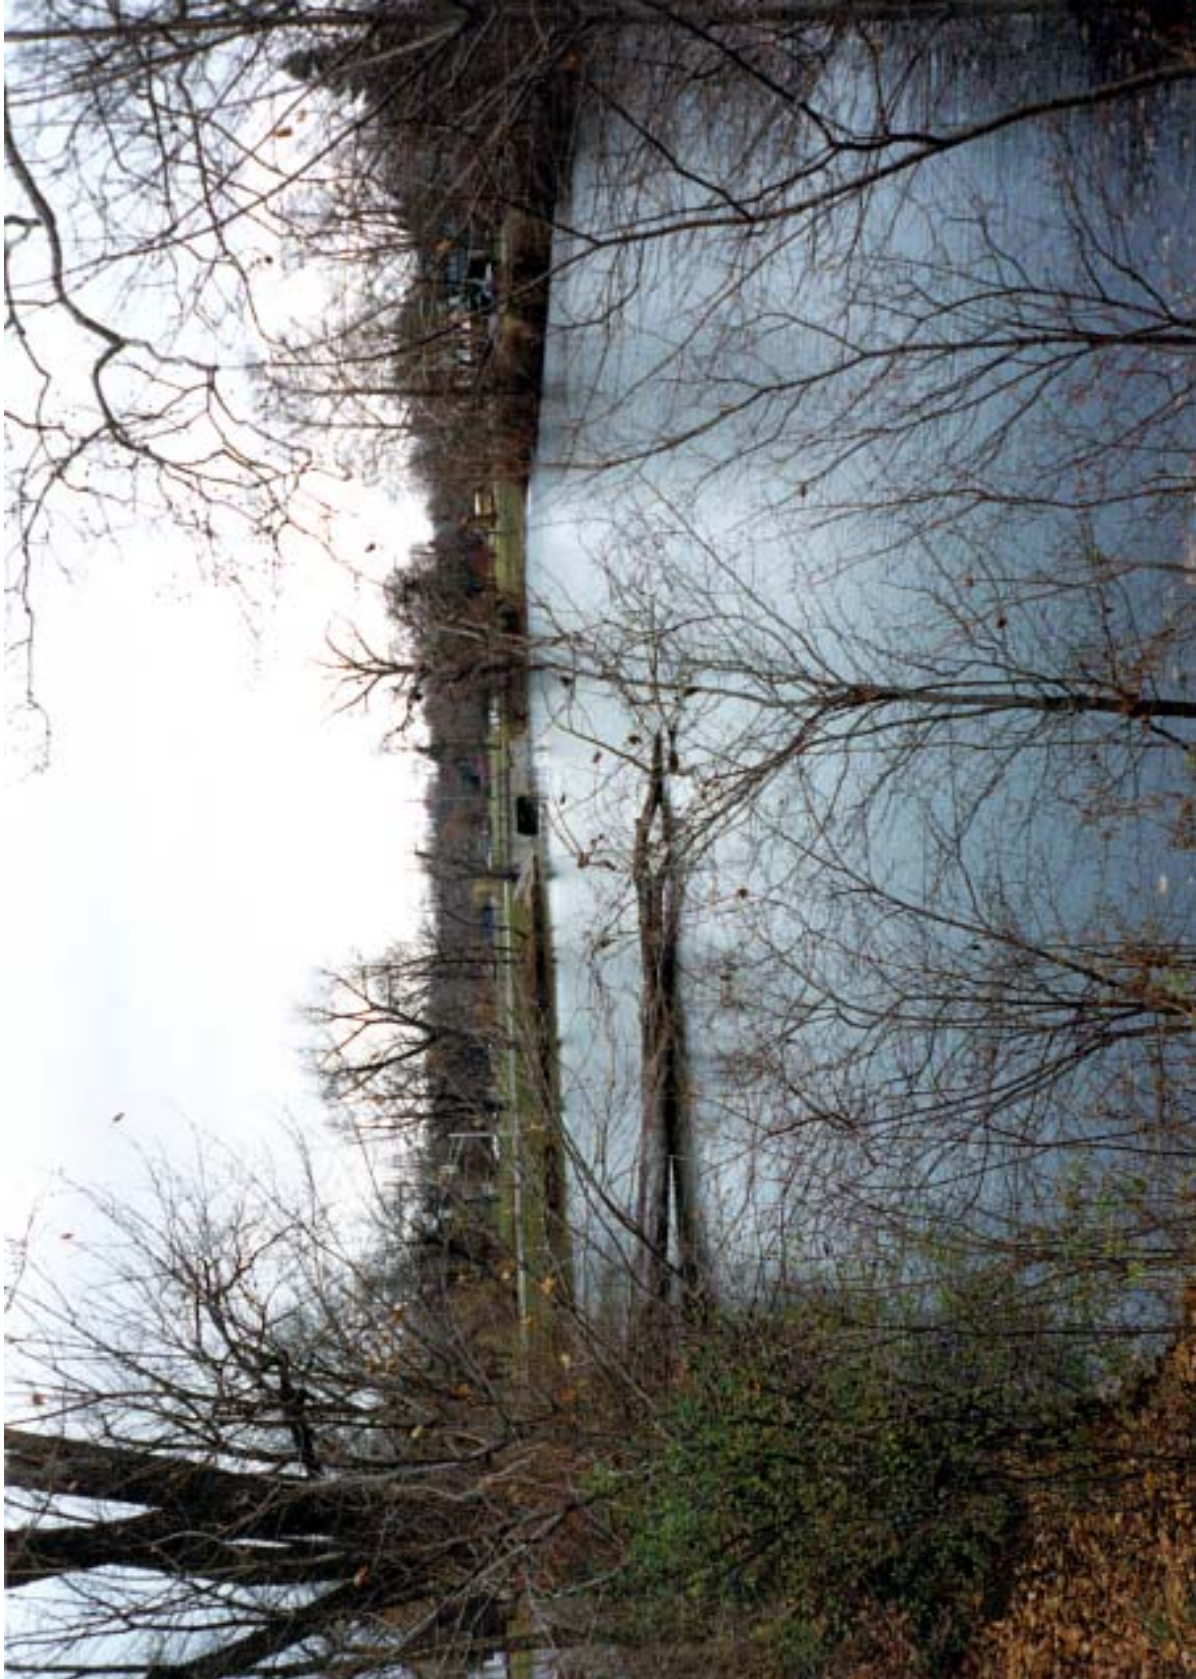
Figure IV.11 Overgrown banks of the southern half of Delta Lake, looking north towards Columbia Avenue. LANDSCAPES LA•Planning•HP.

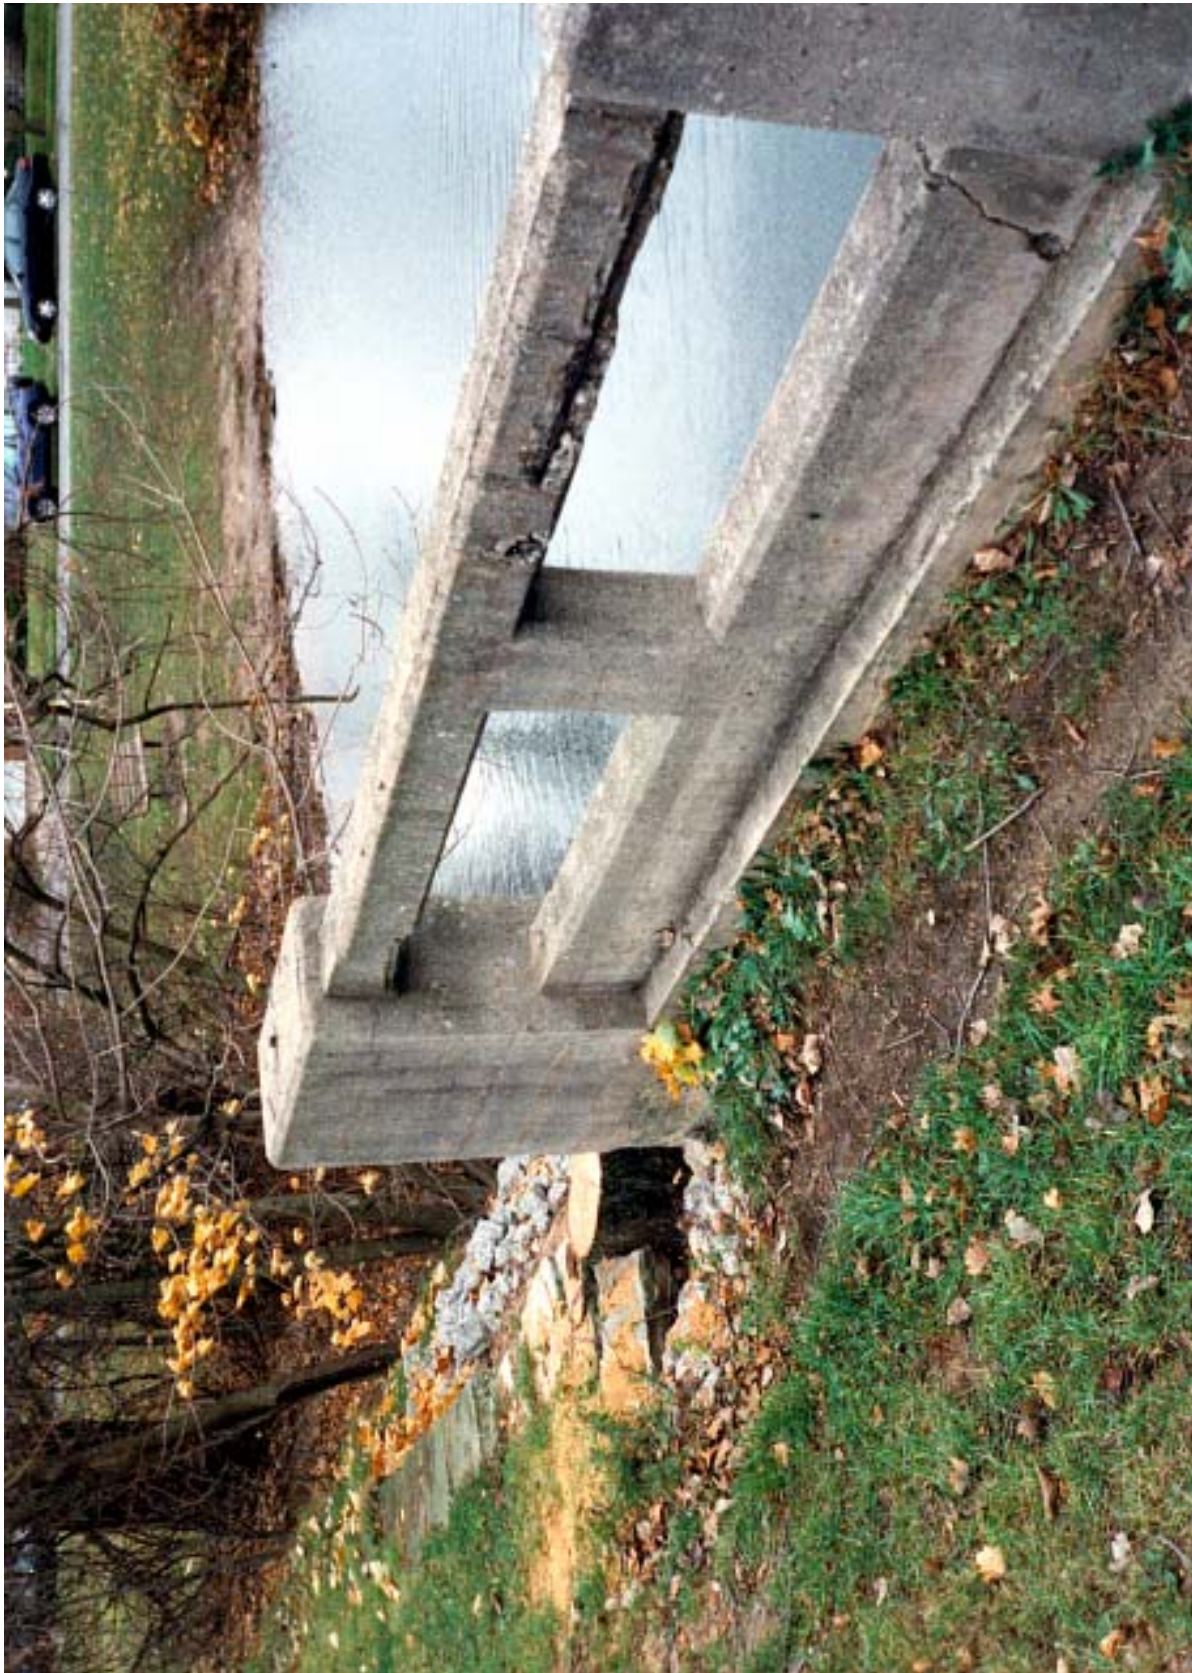
Figure IV.12 Damaged railing and riprap on the bank of the Columbia Avenue vehicular bridge. LANDSCAPES LA•Planning•HP.

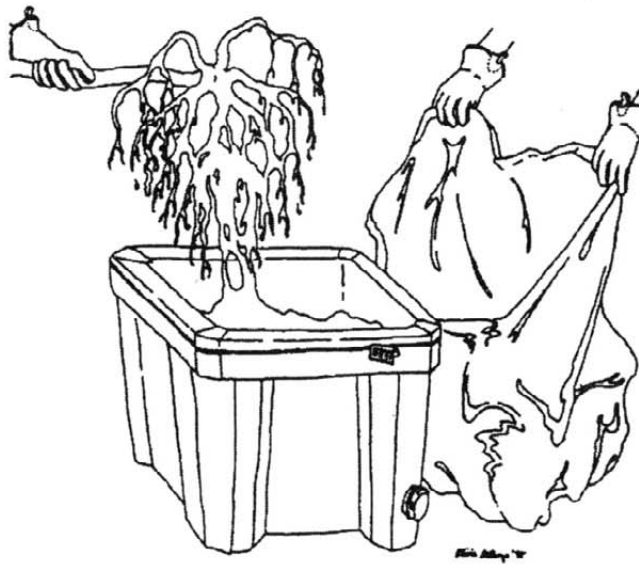
Dipping and bagging at the nursery. Make sure all roots are covered in the hydrogel slurry.

Dipped and bagged trees ready to be tarped and transported. A tarp is essential to keep the wind from desiccating tree tops and roots.

- Dip the root system in the slurry. Don't shake the hydrogel off the roots — you want to leave as much coating on the roots as possible. Immediately slip the roots into a large, pleated plastic bag. Pleated, or gusseted, bags are important — if you use non-pleated bags the roots will poke through the sides. Knot the bag around the trunk to hold in moisture.

- After bagging, trees should be stored in a cool, shaded place until ready to be transported. Stack trees in the truck bed, being careful not to injure bark or break branches. Water down the bagged trees to create humidity in the truck bed. Close the truck bed or securely tarp it for your trip back to the city. Upon arrival trees should be stored in a cool, shaded building until ready to plant. The sooner you plant, the better — but wait no more than a week after dipping.

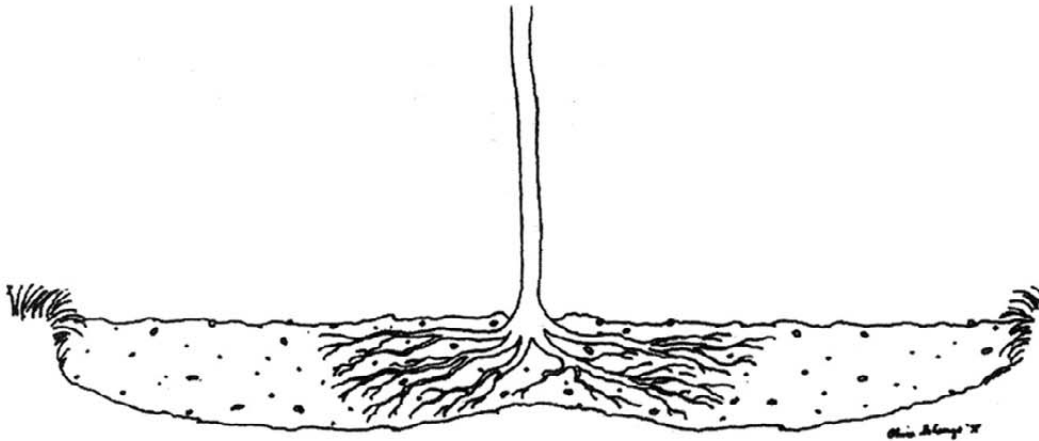
Dig the planting hole shallow and wide, at least three times the diameter of the tree roots. The beginning of the root flare should be at soil level.

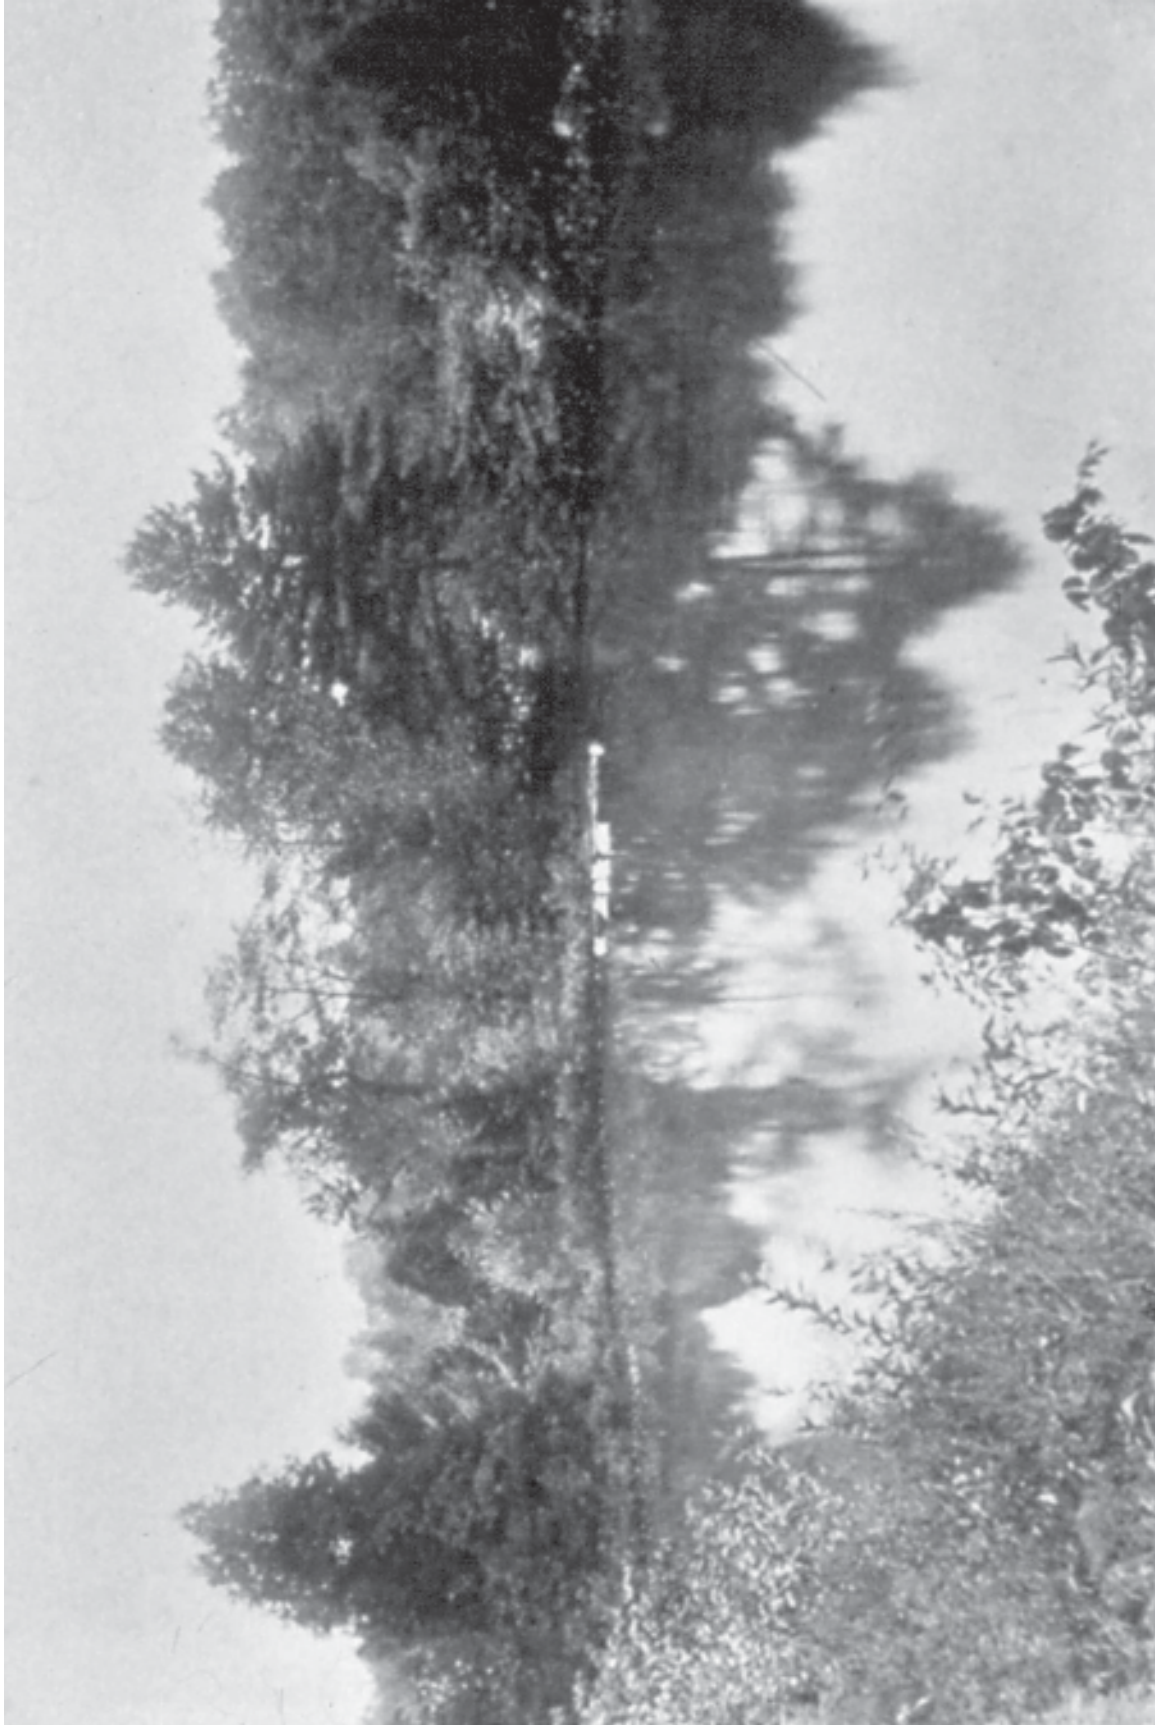
Figure App.C.1 Trout Pond, Seneca Park, with diverse vegetation at water edge and banks, c. 1888-98. Courtesy of City of Rochester Archives.

The following set of images shows an historic view of the planted pond banks, an existing conditions image of the deteriorated pond edges, plan sections showing bank stabilization strategies, and images of construction underway and completed.

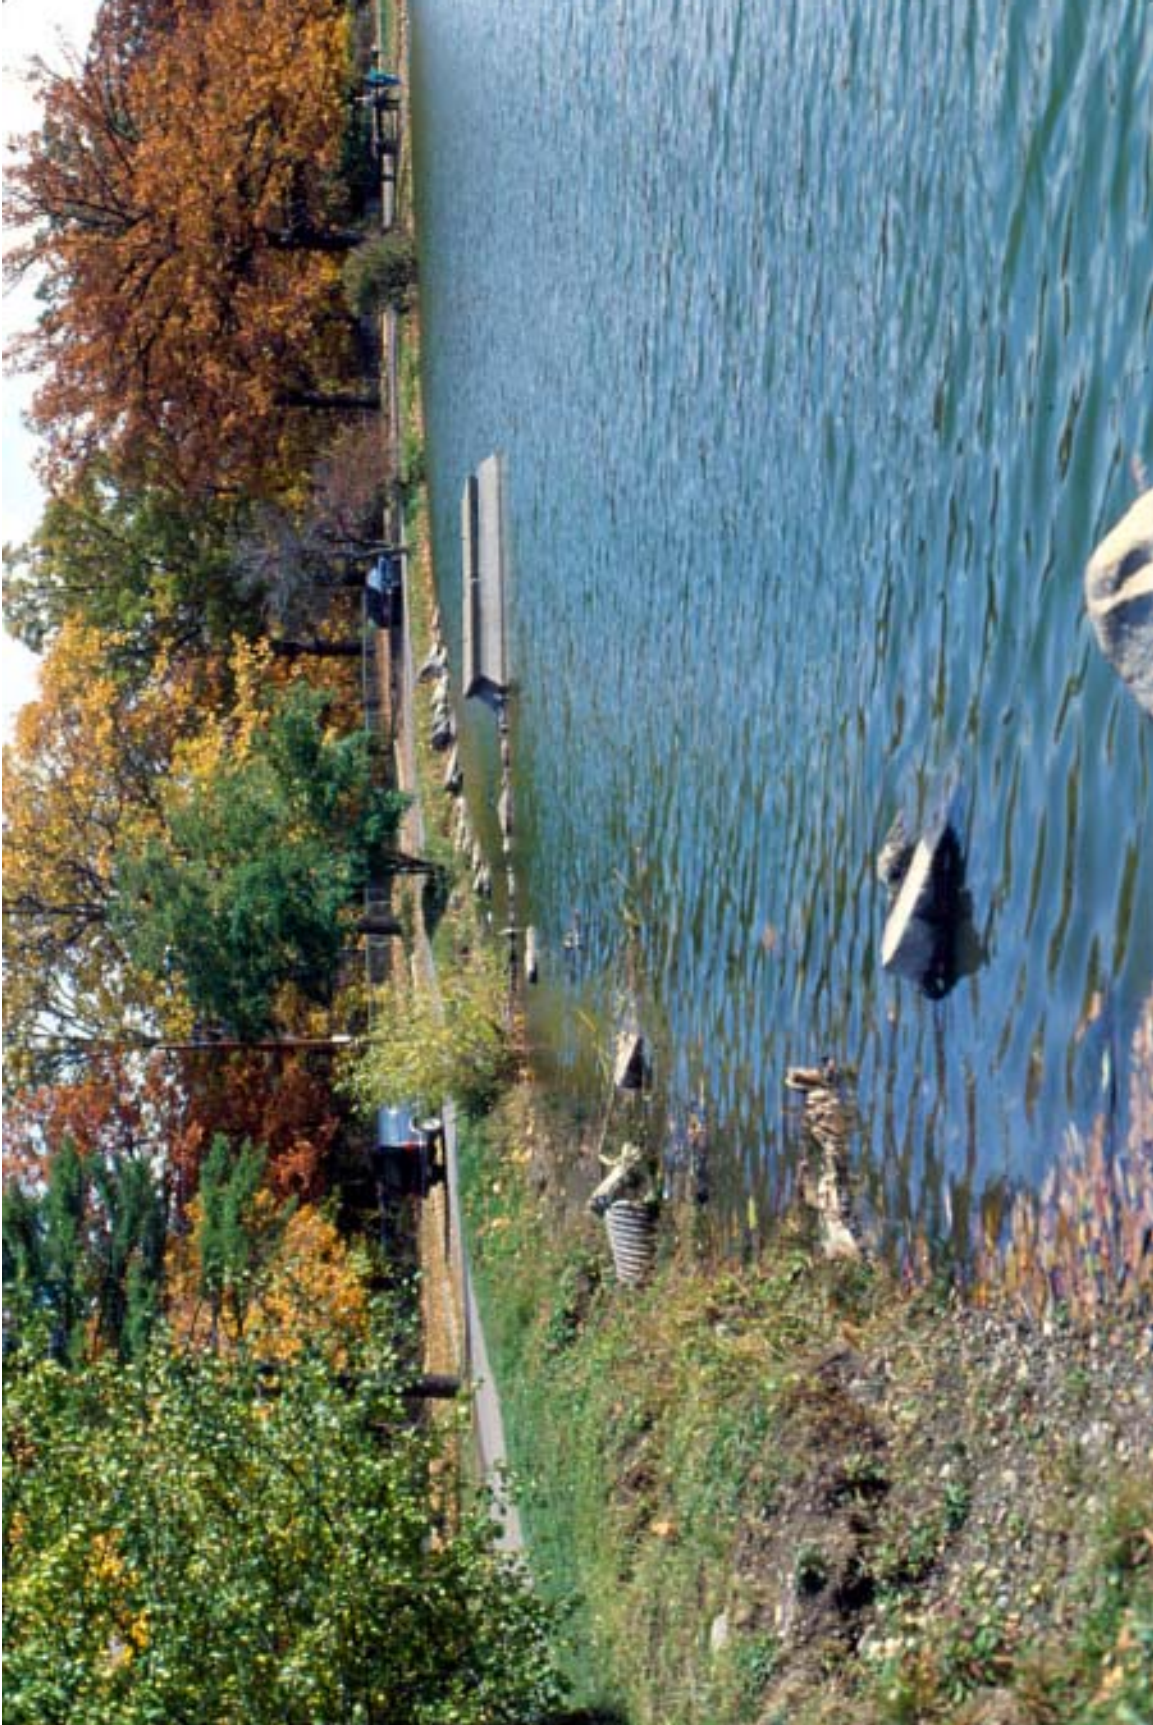
Figure App.C.2 Deteriorated banks of Trout Pond showing eroded edge conditions, 1989. LANDSCAPES LA•Planning•HP.

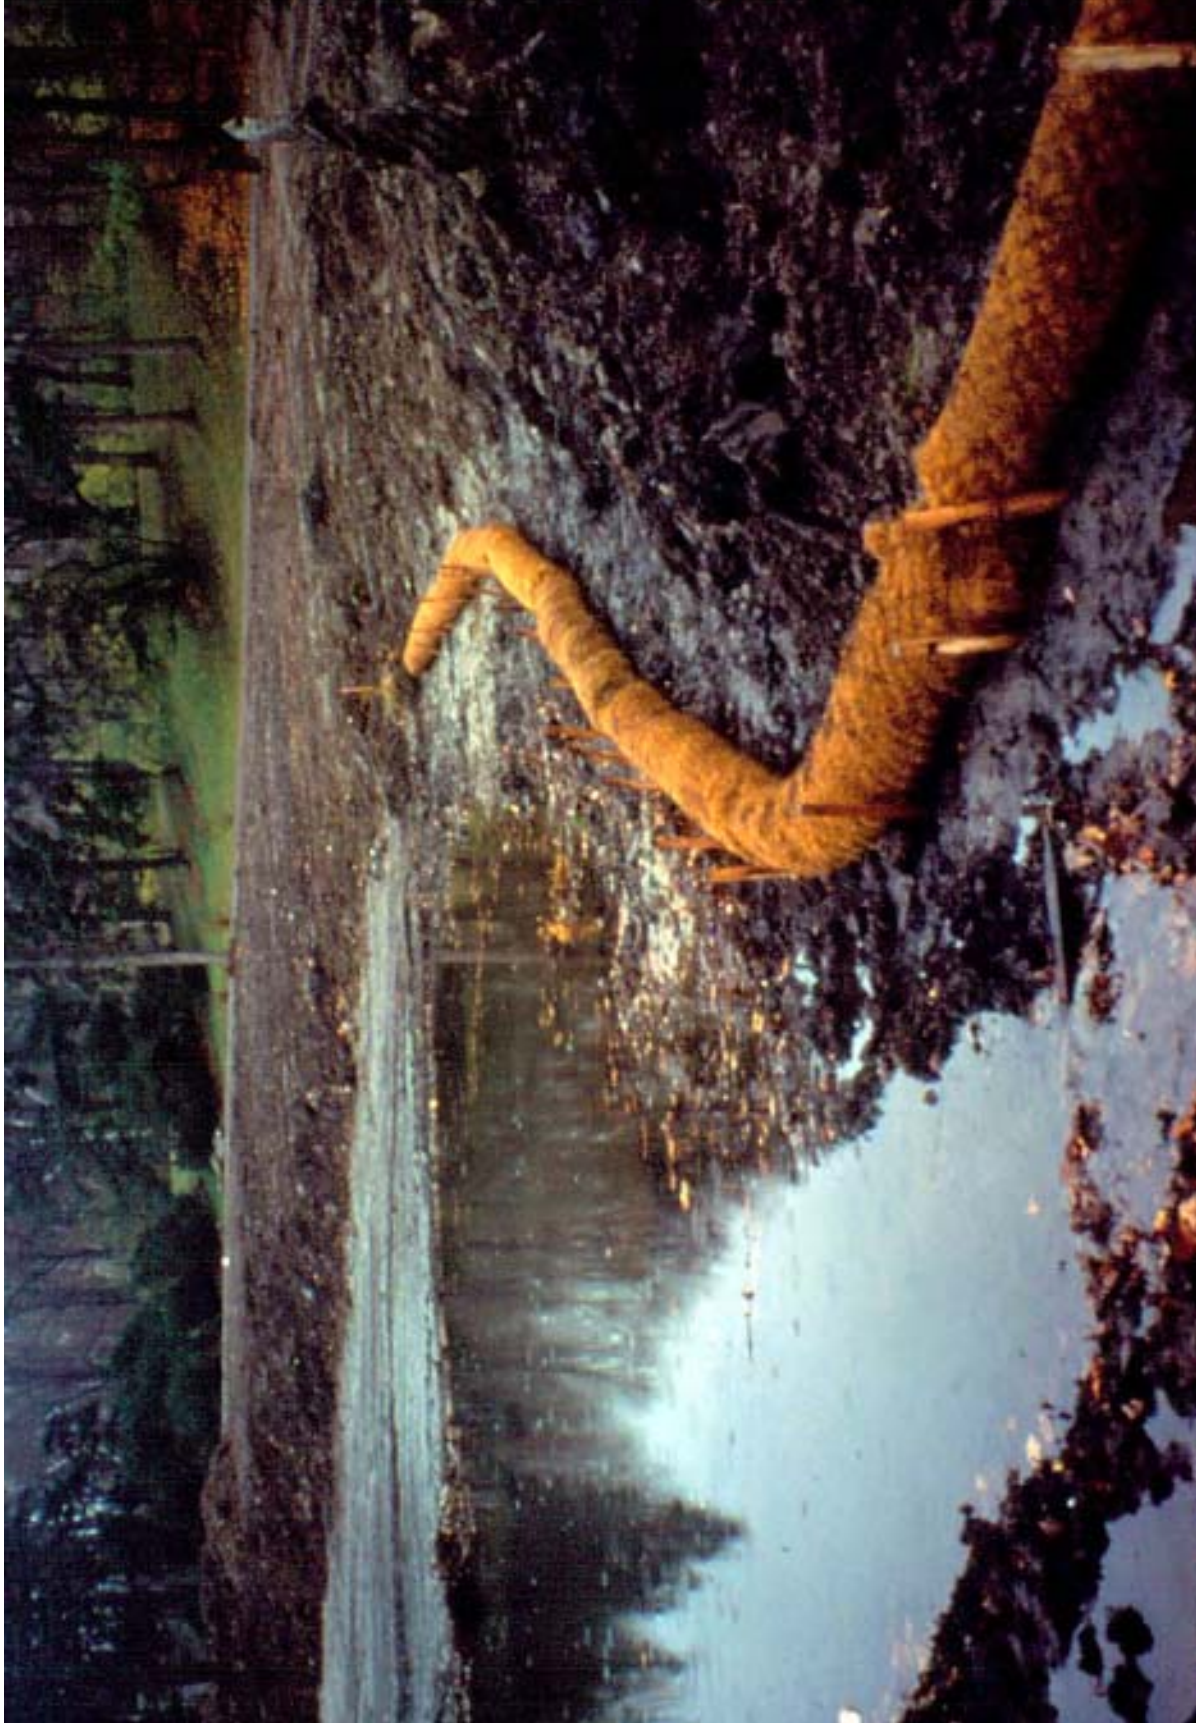
Figure App.C.4 Photograph of bank reshaping and installation of fiber-schine at Trout Pond. LANDSCAPES LA•Planning•HP.

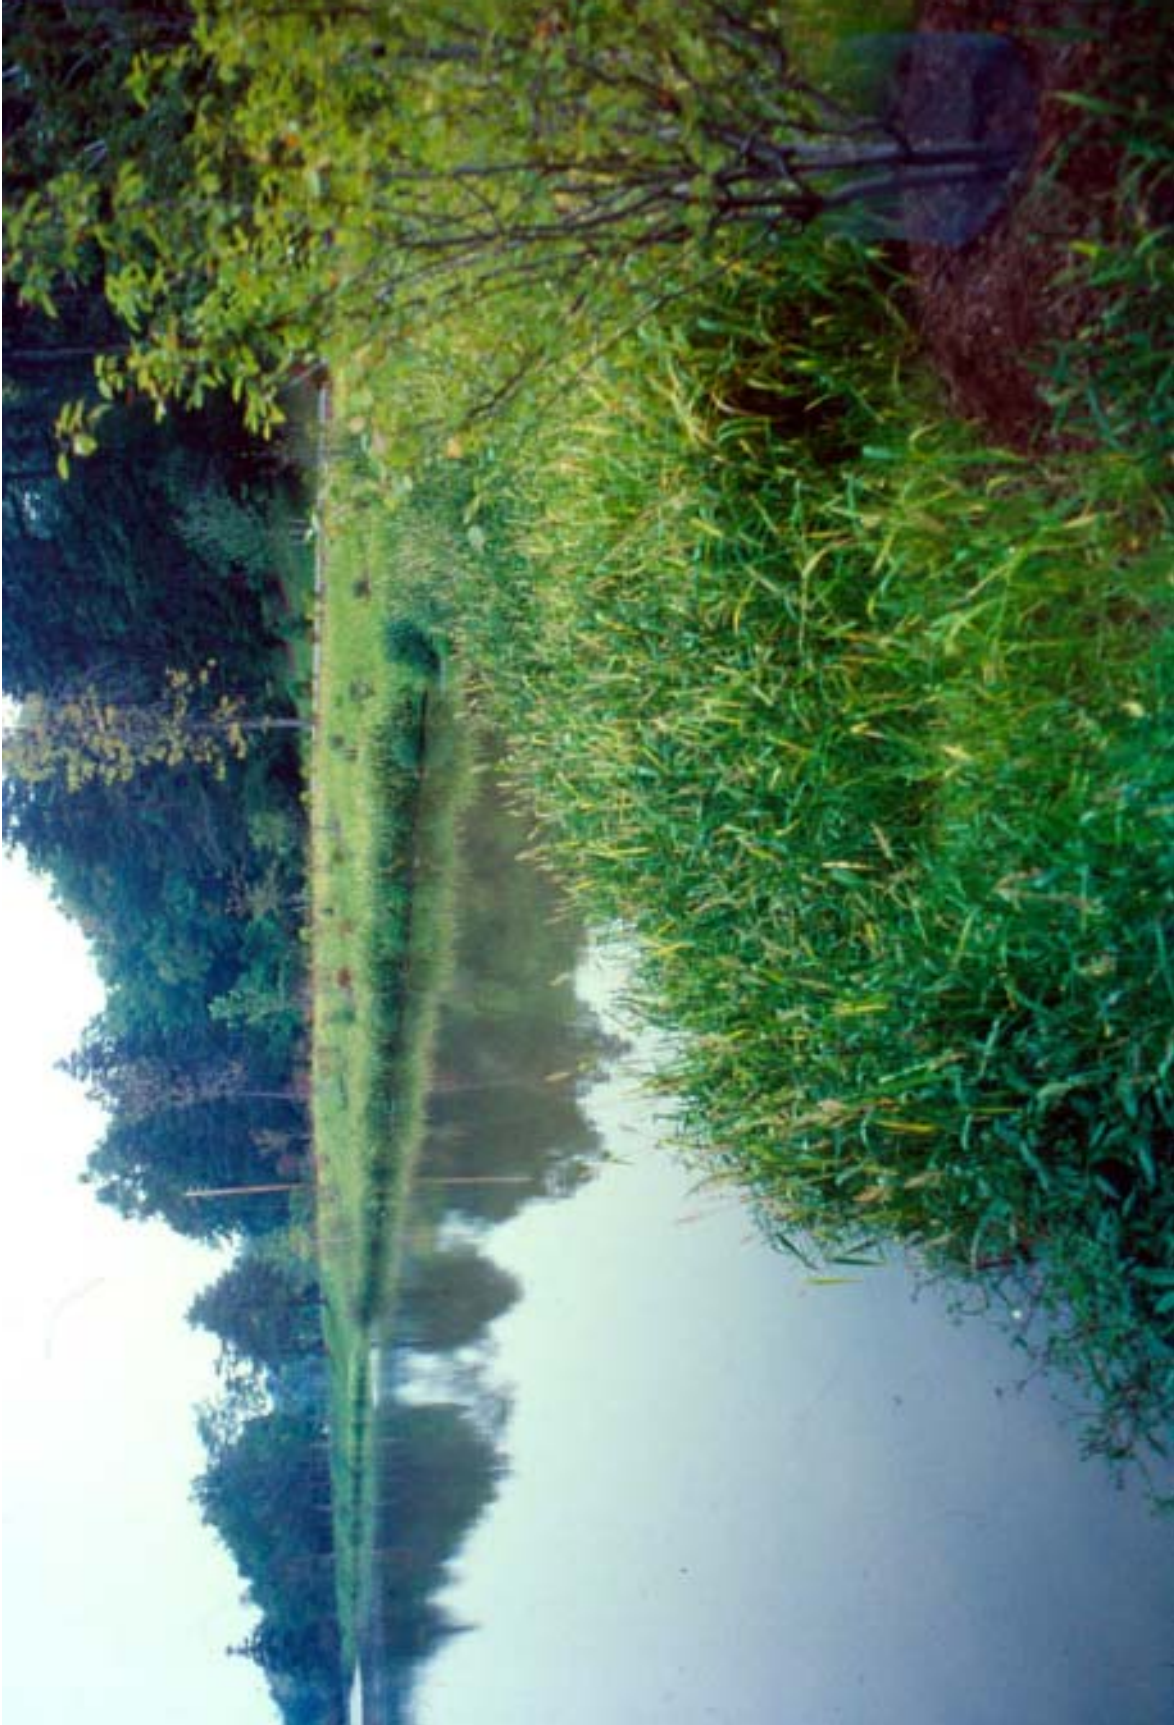
Figure App. C.5 Photograph of Trout Pond bank with stabilized edge and new growth. LANDSCAPES LA • Planning • HP.

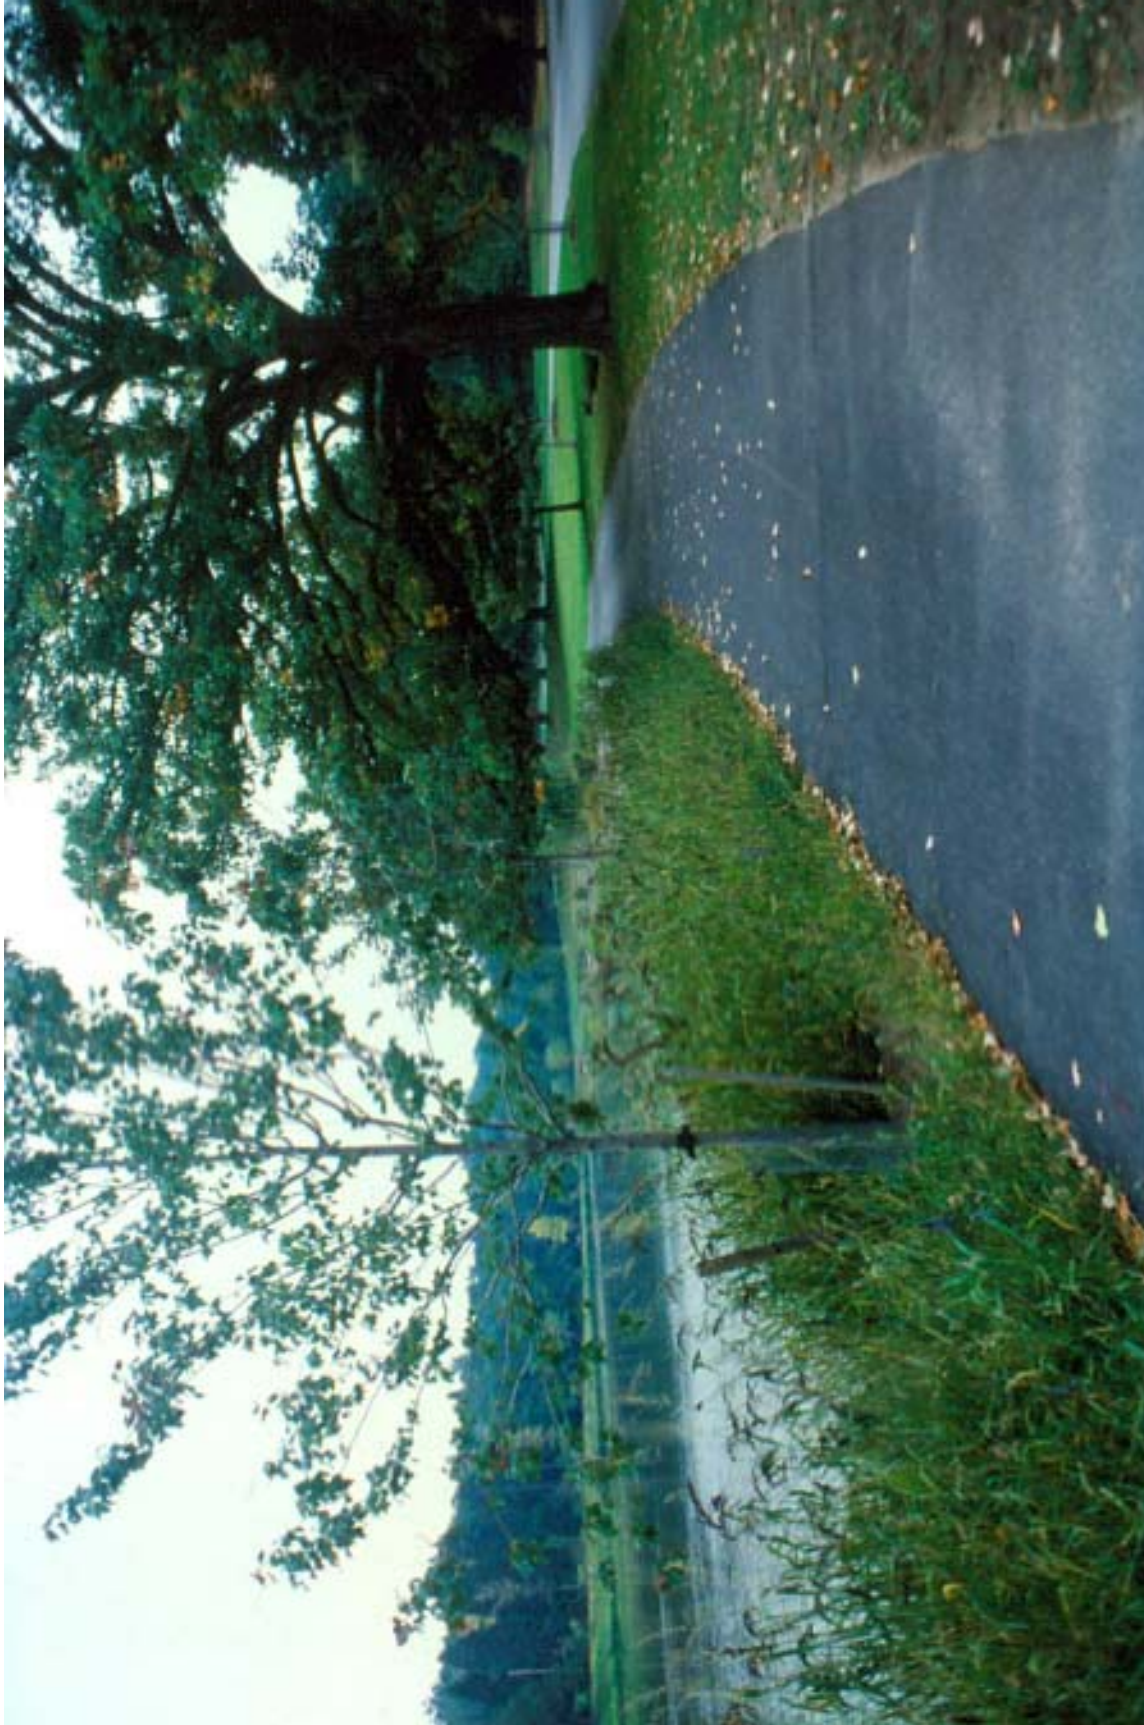
Figure App.C.6 Edge of planting above bank at path, showing infrequent mowing of pond edge plants on left and turf mowing regime on right.
LANDSCAPES LA•Planning•HP.
