LAKESIDE PARK

Cultural Landscape Report

History, Existing Conditions, Analysis & Rehabilitation Plan

City of Fort Wayne, Department of Parks & Recreation
Fort Wayne, Indiana

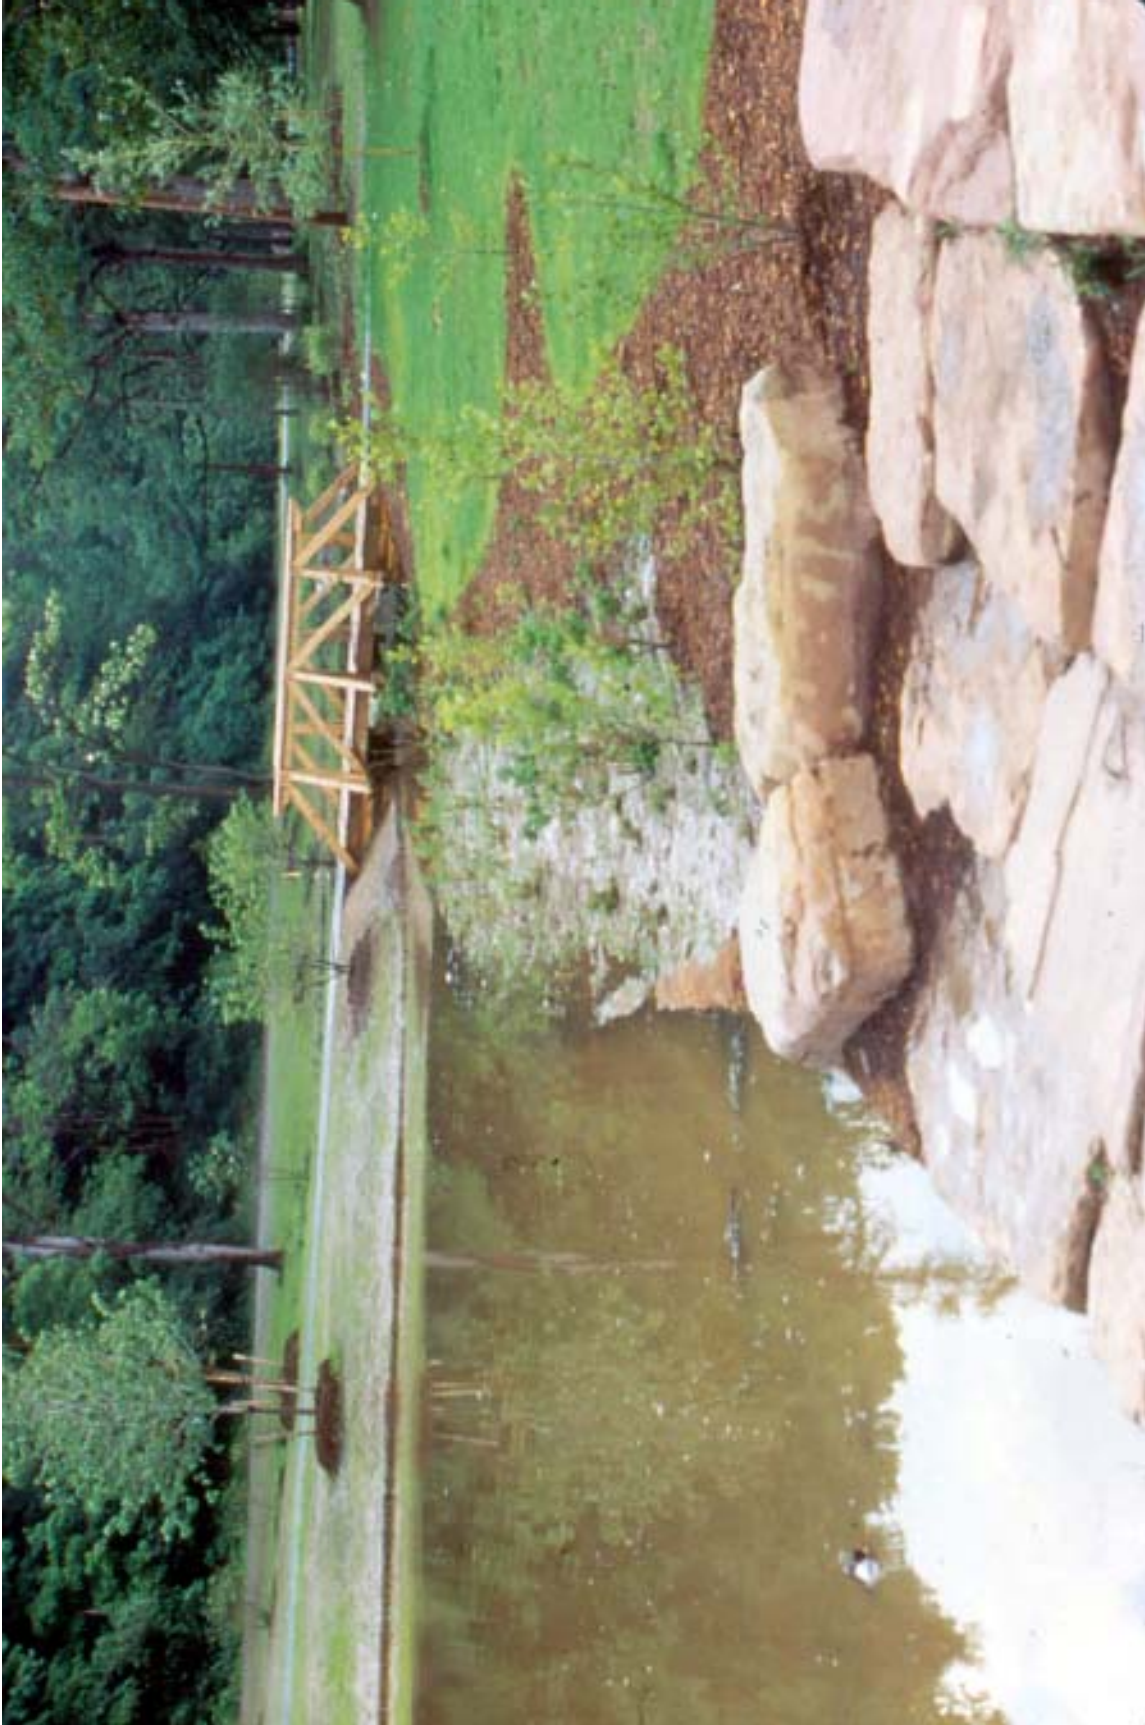
Figure App.C.7 Access area with stone construction shown at intersection with stabilized, planted pond bank. LANDSCAPES LA•Planning•HP.

- Install large, relatively flat stone vertically into pond at water edge and then pave asphalt path up to the stone edge, this detail can also serve as handicapped access with proper grading and edge protection
- Install a series of boulder size stones along edge and for seating and pave around them

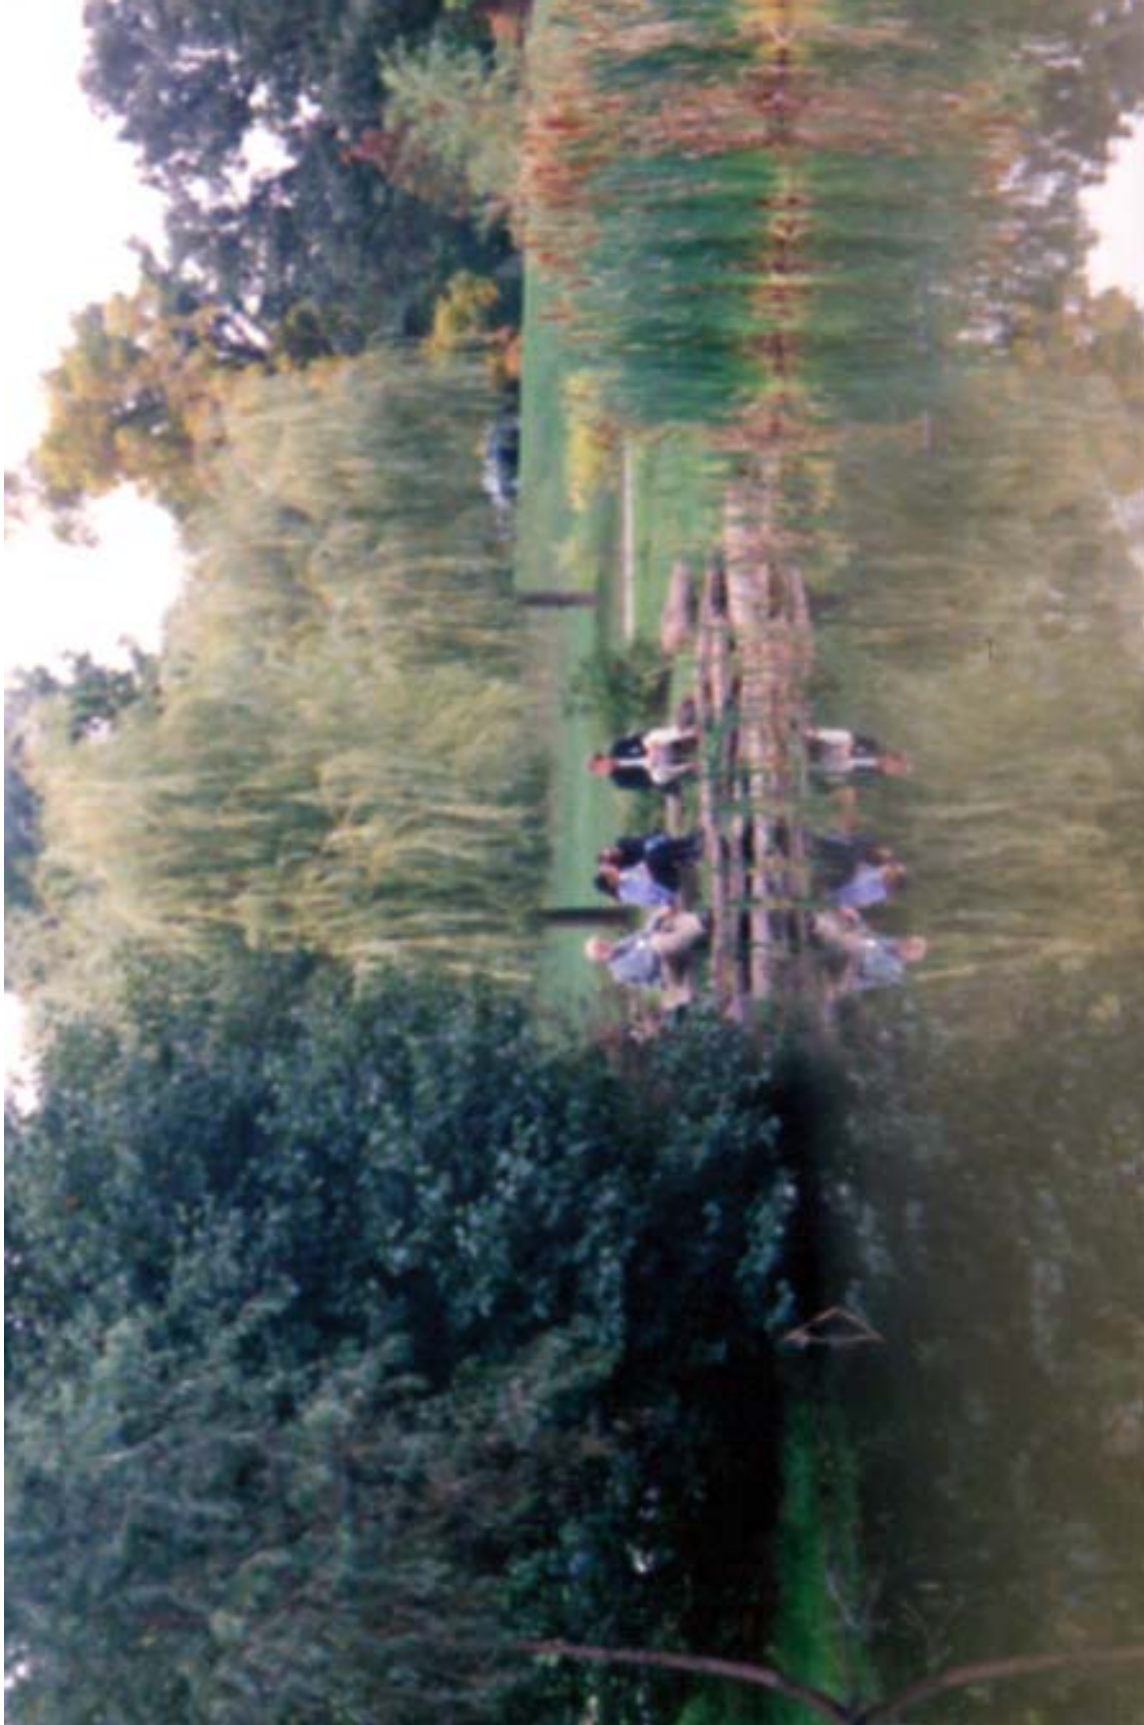
Figure App.C.8 Trout Pond access area and bank as seen from across the pond, showing seating rocks as well as stone armoring. LANDSCAPES
LA•Planning•HP.
